# **Wooden Architecture and Earthquakes in İstanbul**

**A Reconnaissance Report and Commentary  
on the performance of wooden structures in the  
Turkish earthquakes of  
17 August and 12 November 1999<sup>1</sup>**

Stephen Tobriner  
Professor of Architectural History  
University of California, Berkeley  
April, 2000

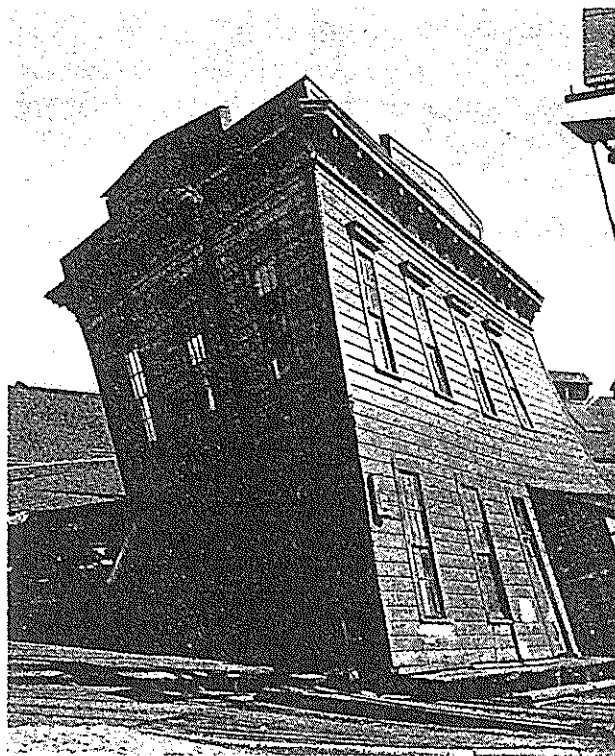
revolutionized in the early 19<sup>th</sup> century in the United States of America by the invention of balloon frame construction.<sup>25</sup> In this system of machine cut 2 x 4 or 2 x 6 inch vertical studs placed at 16 inch. intervals nailed to horizontal members with wire-cut nails (fig. 8) replaced heavy timber members secured by mortise and tenon joinery or spikes. Balloon frame construction was commonly considered to be seismically resistant in earthquake-prone 19<sup>th</sup> century San Francisco.<sup>26</sup> In general wood buildings were only wrecked in earthquakes when their brick chimneys collapsed, when they fell off their foundations, or when basement half-stories constructed with unbaced “cripple” walls, collapsed (fig. 9).<sup>27</sup>

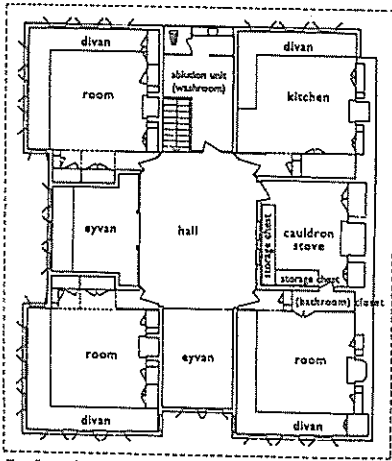
11. Saraçlar house, Şehir district, Safranbolu (after Günay, p. 214)

Further, the *hayat* in Saraçlar şehir house creates a void disrupting vertical continuity because it is two stories high and supports a *eyvan* (hall) on the third story (fig. 12). The middle story is particularly vulnerable. For example, in another Safranbolu house the boarded up *hayat* illustrates the problem in elevation (fig. 13). The *hayat* with its long support columns may not be able to support the floor above it. In that case the *hayat* supports constitute a so-called soft story which might collapse in an earthquake. Note too that the walls of the Saraçlar şehir house present another vertical discontinuity. The middle floor is cantilevered over the ground floor. These cantilevers create a more complicated load path as the walls might rock back and forth in plane (in the direction of the wall) or out of plane (at right angles to the wall). The cantilever projections would tend to “wag” back and forth in an earthquake, stressing their connections to the main wall. These connections, called reentrant angles, might be stressed to the point of

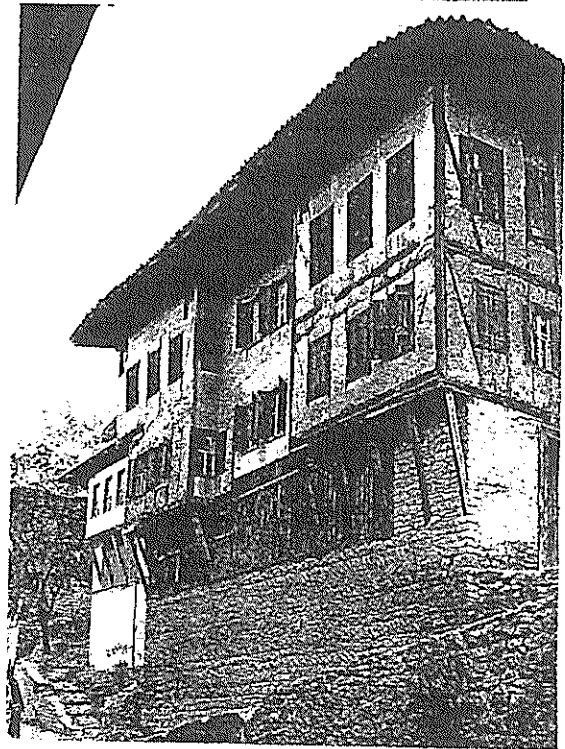
14. Hacı Kadılar house, Şehir district, Safranbolu (Günay, p. 223)

collapse. The şehir house of Hacı Kadılar illustrates another problem with these projections (fig. 14 ). Imagine the walls of this house being pushed in plane and out of plane. Because they are discontinuous with the stone foundation their weight comes down on the diagonal braces embedded in the wall. This uneven load could push the wall inward, collapsing it. Where multiple cantilevers occur, as in the Antepier house (fig. 15), danger of discontinuity increases.

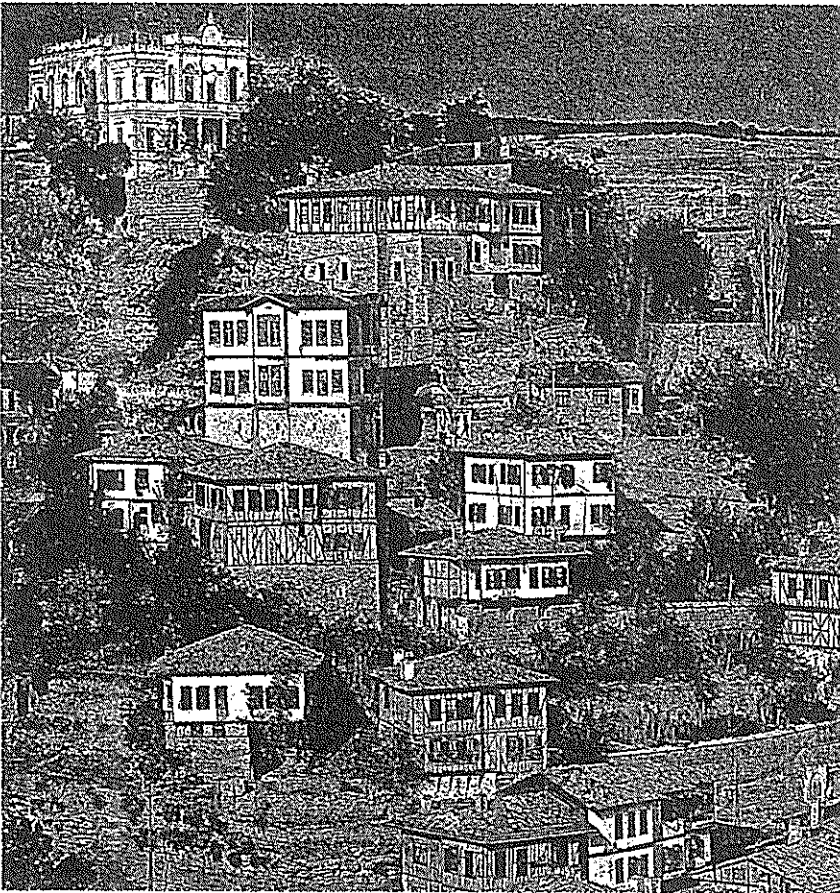
The masonry ground floors of the houses of Safranbolu present two problems. Some ground floors are exceptionally high because houses are sited on steep slopes (fig. 17) which means that the structure has a high height to base ratio. This creates an inherent instability in the structure as a whole as it increases the probability of rocking. But even more difficult to judge and potentially more dangerous is the masonry construction of the ground floor. In an earthquake will the masonry be able to function as a unit or will it shatter in pieces? Masonry is brittle and composed of a myriad of individual rocks, commonly rubble, held together by weak mortar. Sometimes strips of wood run through the courses of masonry (fig. 18). When I first saw them I thought they might be bond beams, tying the building together. But they may have been used to simply level the courses of stone at given intervals. Their insertion in the wall probably further weakens it. In the United States the construction of the masonry ground floor would be called "unreinforced masonry." Under California law older brick buildings of this type of construction must be reinforced and the usual method is with concrete or steel. Engineers

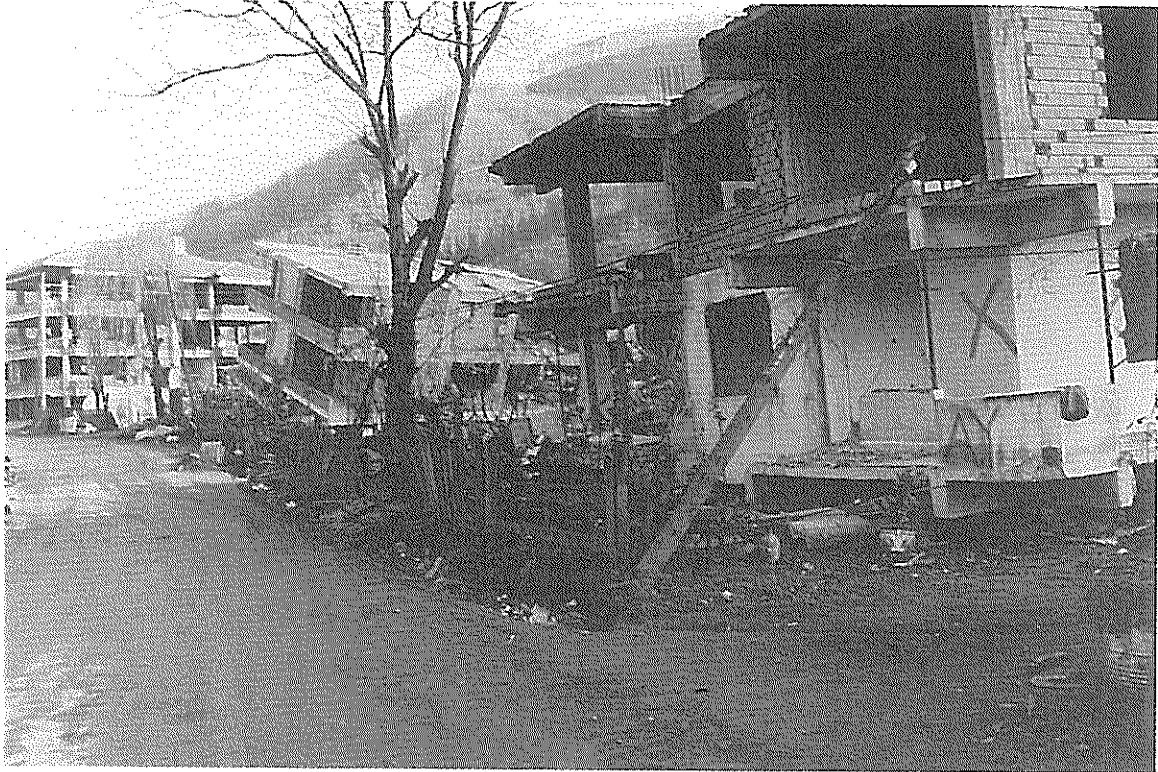
Although damage was considerable on both sides of the highway, with about 20 per cent of the buildings collapsed, the most spectacular damage was concentrated along the stream banks to the south. Here the reinforced concrete buildings of four to five stories failed at the ground floor causing many to settle one story (fig. 21). Citizens told of many people dying in these first stories because they were watching a soccer match in

small ground floor bars and restaurants. But many of the failures were in structures that were as yet incomplete. The lack of concrete shear walls combined with weak columns in both the incomplete and complete structures was the cause of collapse. The upper stories of the reinforced concrete buildings were for the most part still intact although obviously askew.

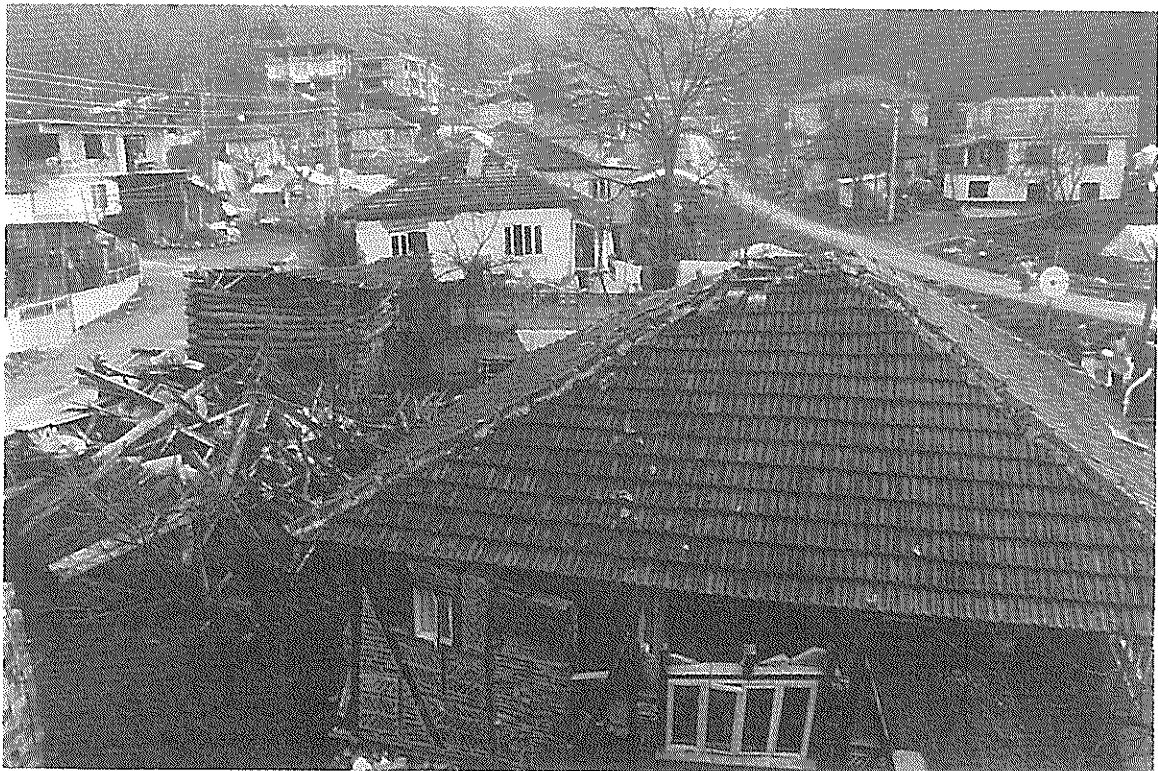
Because Kaynashlı is a poor farming village it retained many wooden buildings in its housing stock and a dozen of these ascended the picturesque stream south up a hillside (fig. 22). Because they were on alluvial soil the shaking must have been intense. However they seemed to be excellent candidates for surviving an earthquake of considerable magnitude. These wooden buildings were very similar in design. They were one or two stories structures with square or rectangular ground plans, hip roofs and a moderate ratio of apertures to walls of 1.5 to 3. They were far smaller than the houses in Safranbolu and in every way more modest. They had none of irregular or discontinuous features (like cantilevered upper stories or *hayats*) that characterized older Turkish wooden houses. These were regular blocks, probably with westernized floor plans, some so modern-looking that they appeared to be reinforced concrete apartment blocks. Their states of repair varied from excellent to extremely poor. All were of frame construction with heavy timber members and at least two diagonal timbers on each side, one was sheathed in wood. Some had an x brace or two on each side (fig. 23). In addition the interior walls were braced with diagonals. The infill was mostly brick sometimes stone and mud often artfully arranged in the wooden frame. Their responses varied but in general were no better than the reinforced concrete buildings. Most two story buildings lost their ground floors (fig. 24), some lost the diagonals or x braced shear panels (fig. 25) while others slipped off their foundations. In at least three cases reinforced concrete structures hit or pounded against the timber frame buildings collapsing them (fig. 26). There were some notable successes: In one case a concrete building lost its first story sending heavy debris into a derelict timber frame house which in turn collapsed against another timber frame house shoving the second story sideways. Although the last building lost plaster it remained standing. Where the buildings were well built, one story, and had

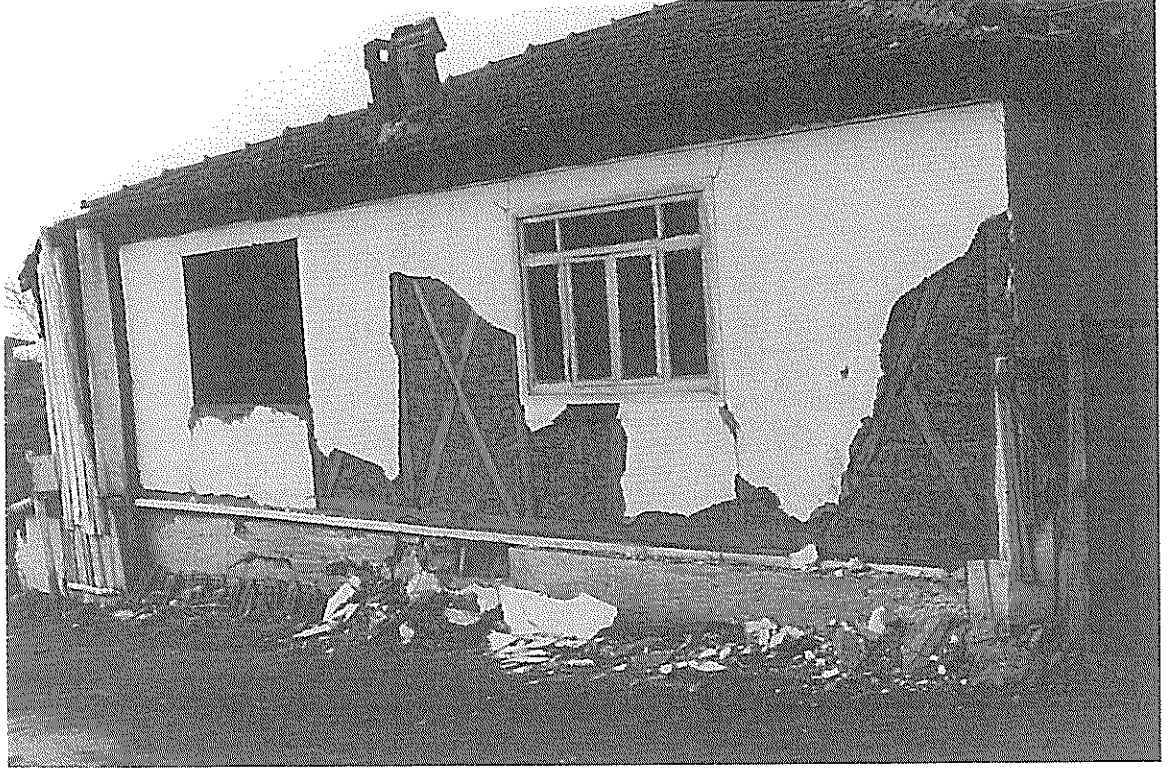
foundations that did not fail, they had a chance. The patterns of damage (broken plaster, lost panels) clearly show the diagonal panels taking the lateral load (fig. 27). Sometimes, even in failure they dissipated enough energy to save the rest of the wall.

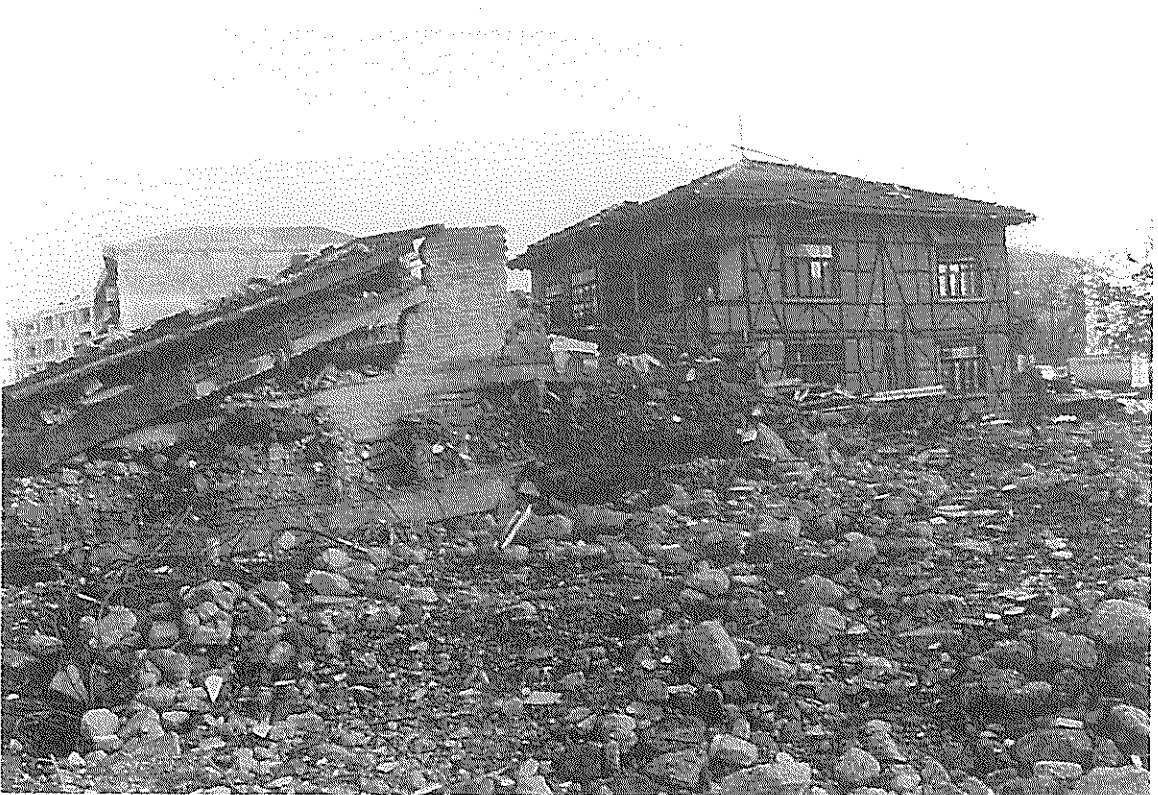
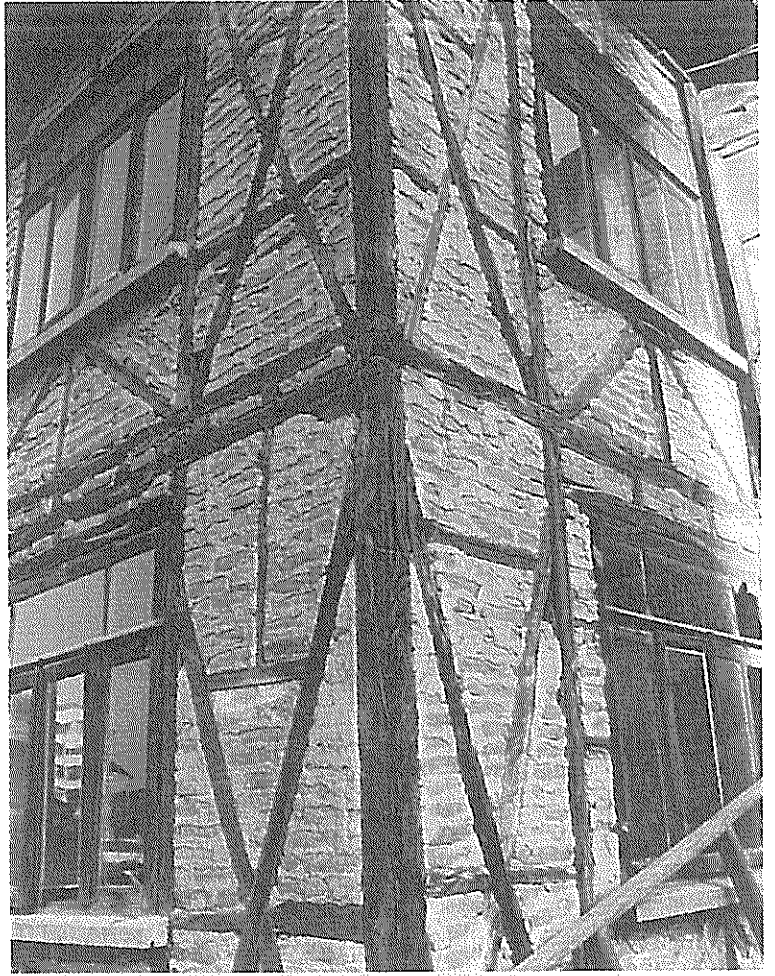
The wooden buildings in Düzce included a type which can also be seen along the road to Kaynaslı. These were square or rectangular apartment buildings of two stories with multiple entrances invariably painted green (fig. 28). There are hundreds on the outskirts of the Düzce, perhaps built as some form of public housing dating from the period of the 1920s and 1930s when, in order to contain foreign debt, the Union and the Progress Committee under the government of Atatürk encouraged a renewal of native building techniques and materials.<sup>36</sup> These buildings are quite different from the houses of Safranbolu in plan and elevation. As in Kaynaslı, these buildings are quite simple and unassuming. But note that their windows are placed well in from the corners and at wide intervals, making it possible to load the walls with x braces and diagonals which helps to make these buildings much more likely to resist earthquakes than the historic structures at Safranbolu. Several of these buildings survived in the downtown section of town near the river, sitting damaged but still standing among the ruins of collapsed reinforced concrete apartment buildings. Concrete buildings on three sides of the building illustrated in fig. 29 collapsed. Its neighbor (fig. 28) also survived, with its broken plaster finish exposing where the braced frame took the forces. Another strange contrast could be seen just next to the river where many reinforced concrete buildings pancaked. In back of the ruins of a

pancaked reinforced concrete apartment building stands intact an elaborate but today derelict wood frame building (fig. 30, 31).

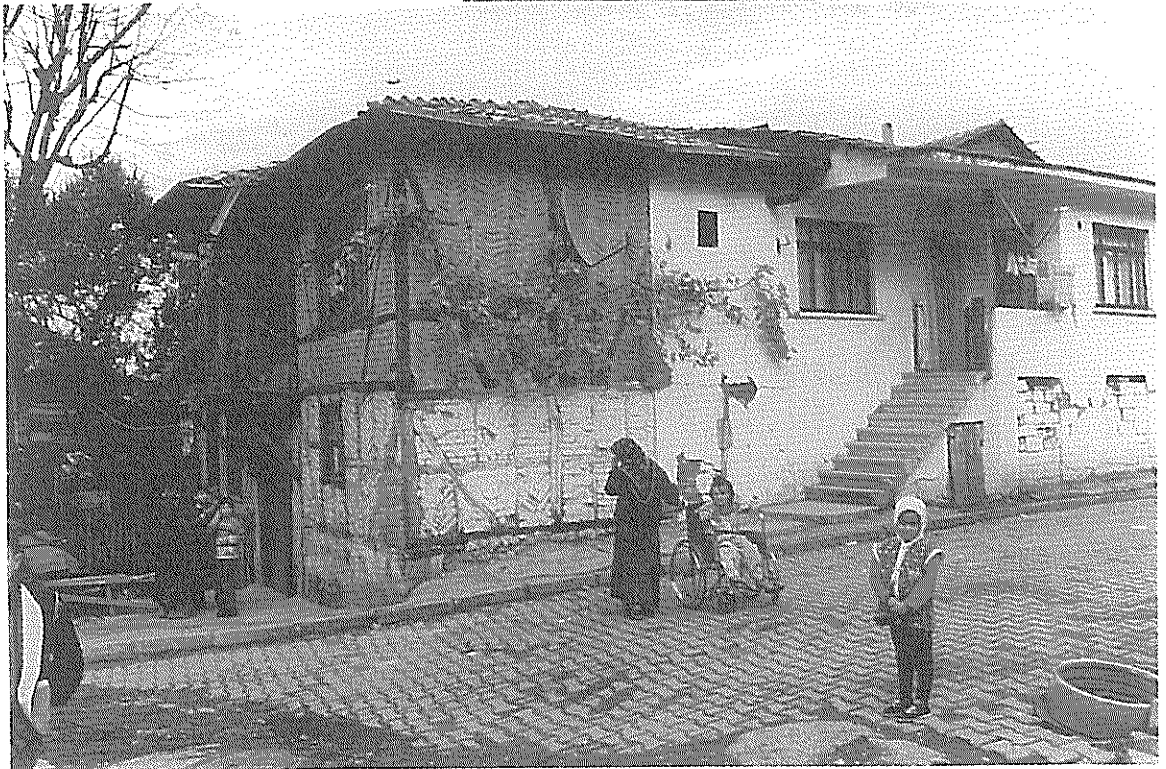
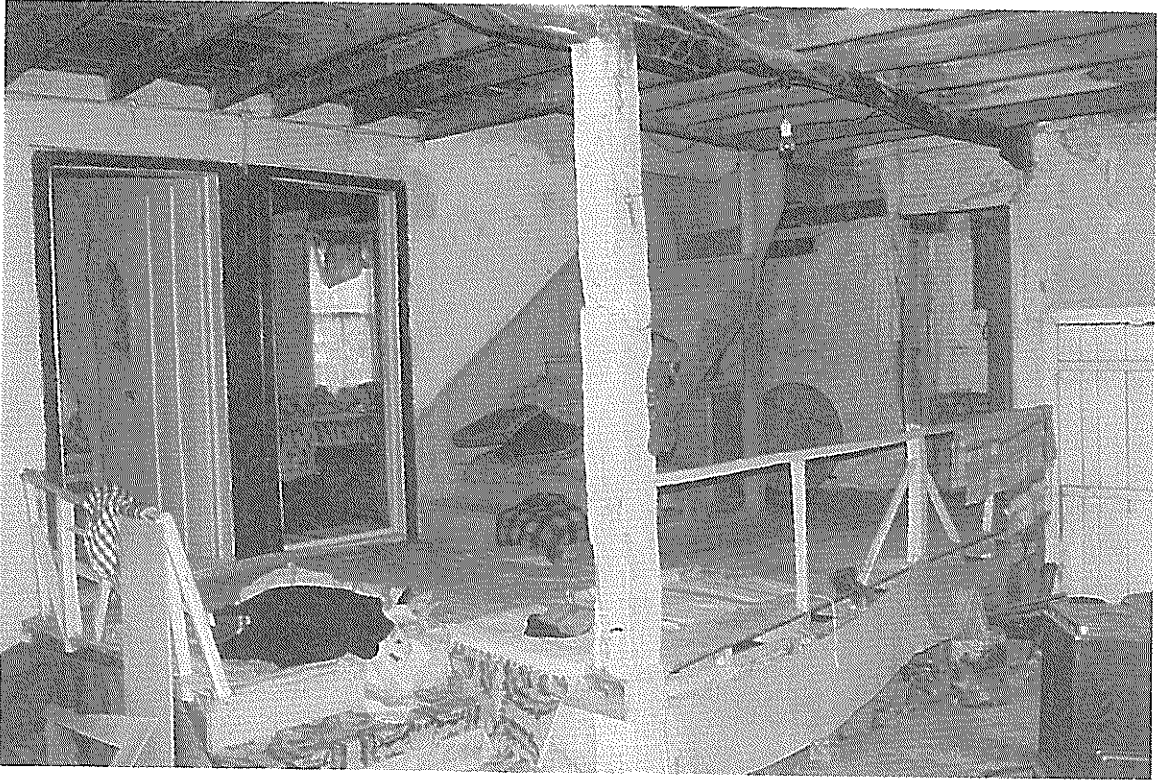
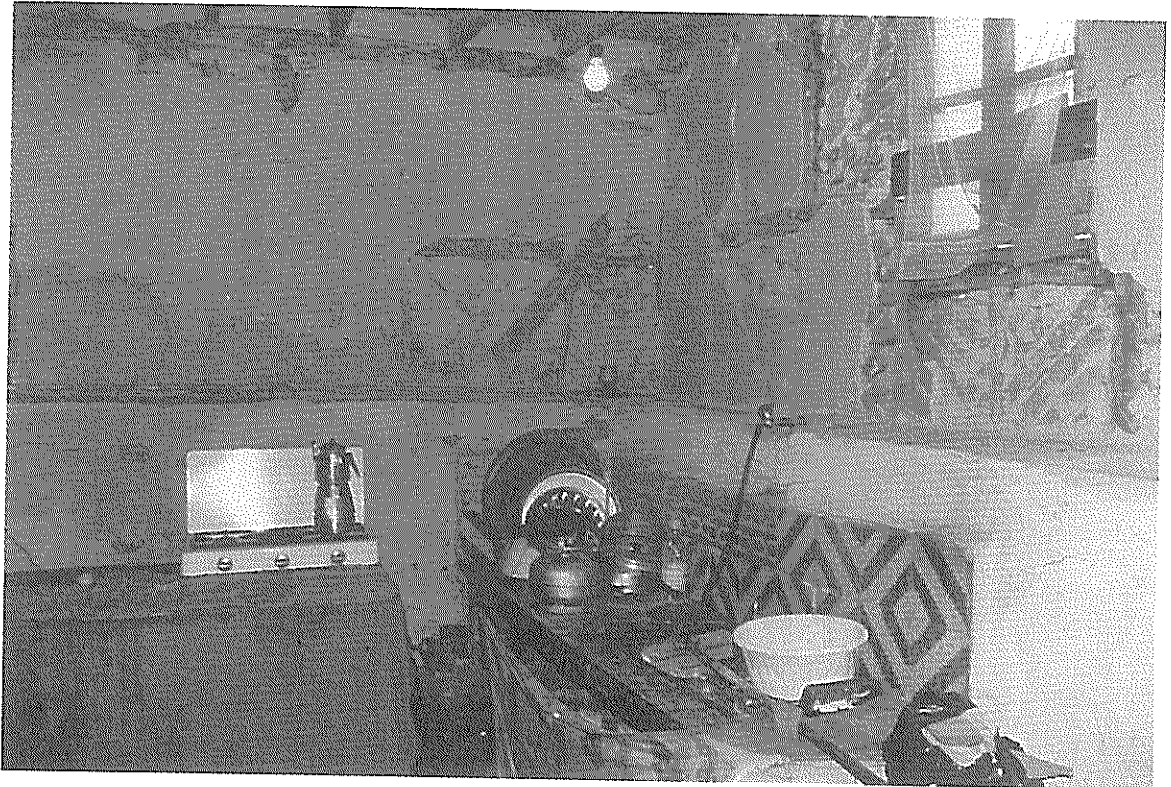
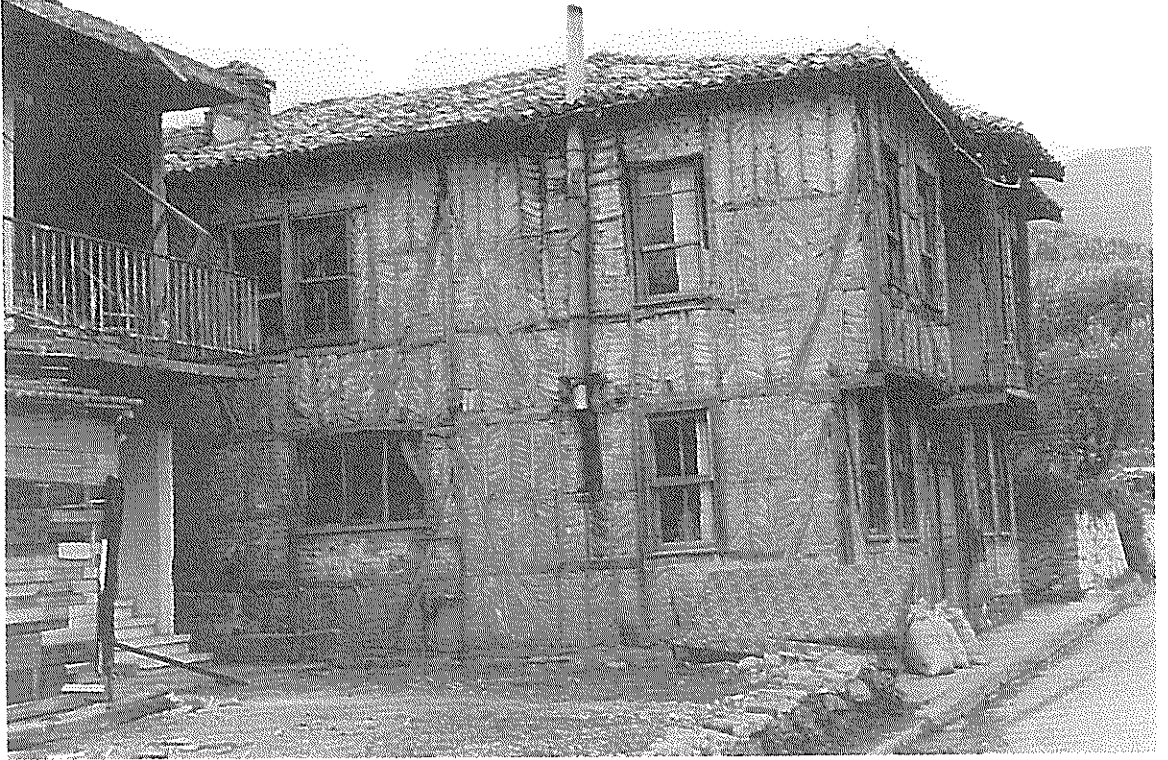
Two structures, both with concrete additions, illustrate the pre-collapse damage patterns of timber framed buildings. The first is a two story rectangular building, wood framed with brick infill in a herringbone pattern in the front, probably brick and reinforced concrete in the rear (fig. 32). Cantilevered over the doorway is a timbered porch corresponding to the *eyvan* or hall. One enters the ground floor (fig.33) (perhaps a version of the *hayat*) and finds steps and a raised platform to the left. The center of the floor-joists is supported by a rough-hewn beam in turn supported by a single post with braces. On the right against the outside wall is the kitchen (fig. 34). The working of the diagonals in the earthquake dislodged the plaster as the house oscillated. A similar pattern can be seen in the back bedroom on the left hand side. In the front bedroom the vertical timbers on the exterior wall began to rotate. In the second, slightly larger house (fig. 35), the entire second story front facade with its wooden porch, is cantilevered over the ground floor as in older traditional buildings in Safranbolu and İstanbul. Diagonal bracing appears at the corners and in the center side elevation of the building. The ground plan and structure resemble the first house. Here the main cracking seems to be along the front facade and rear of the building with diagonal cracks at corners, probably where diagonal

timbers are located. While some plaster fell and the buildings obviously moved they are not collapse hazards.

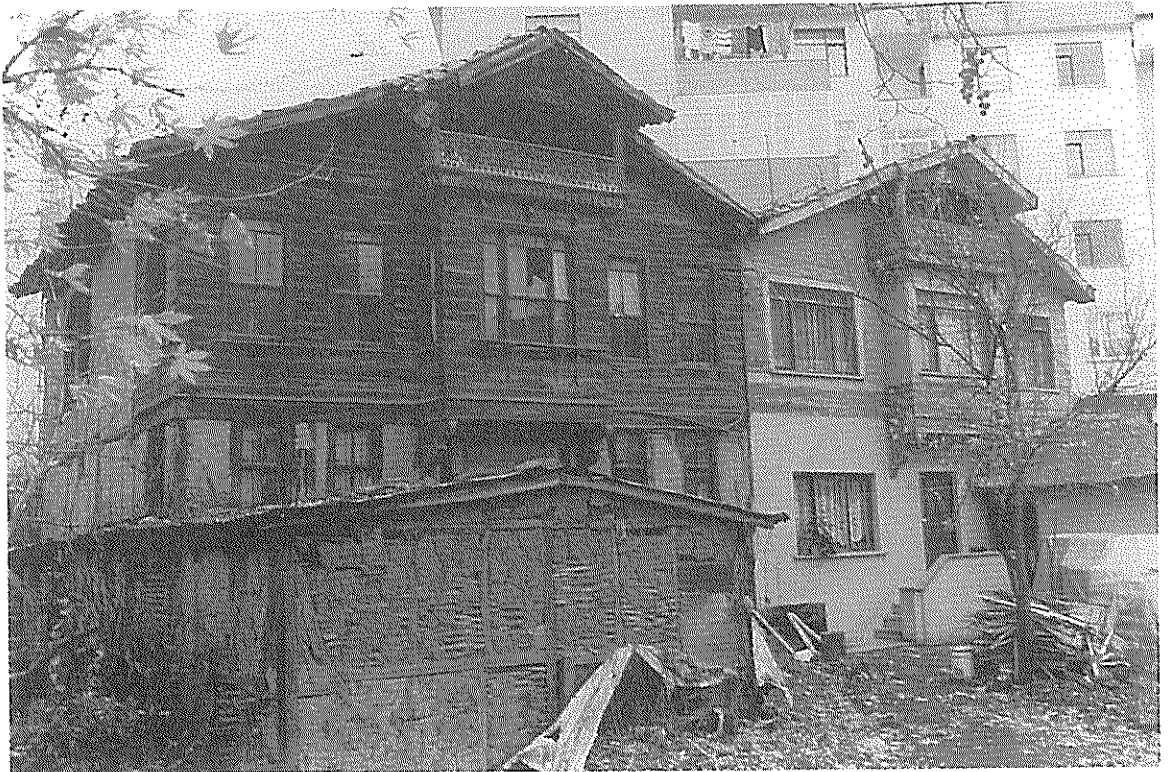
36. Timber frame house, Degirmendere

The downtown of Degirmendere, a seaside city not far from İzmit, was badly damaged in the August earthquake. Like Düzce, wooden buildings stood alone in areas where they had been surrounded by failed concrete buildings, now abandoned or demolished. In one downtown area a collection of buildings survives (fig. 36), some obviously lower class, others more sumptuous, two stories tall with central cantilevered porches probably corresponding to *eyvans* under gable roofs. The latter probably date from the art nouveau period of the late 19<sup>th</sup> century. They appear undamaged from the earthquakes, but a group of reinforced concrete buildings beside them also fared well enough to be re-inhabited. In Degirmendere the wood frame is infilled with wattle and daub, making it far lighter than the brick and rubble infill walls seen in other locations.

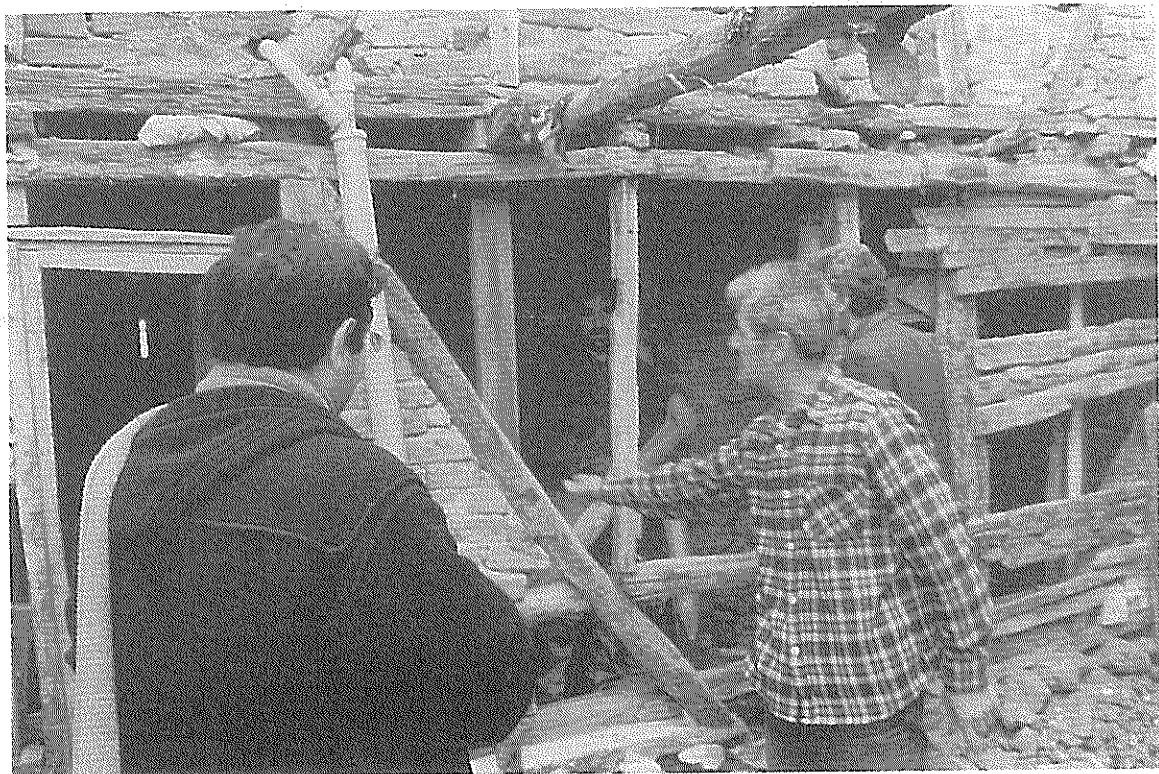
40. Carpenter and diagonal of timber frame, Ulaşlı

In the area struck by the earthquakes of August 17 and November 12 traditional construction is still being practiced, if marginally. A professional carpenter repairing a building in Ulaşlı explained the slightly bent diagonals of Chestnut which are common in the town are intentionally selected to put spring into the wall (fig. 40). Nearby several temporary one story timber framed buildings with Styrofoam infill covered with plastic repeated the tradition configuration of diagonal bracing found in Turkish houses. It was instructive to see the pattern because it indicated that traditional construction techniques were alive and well (figs. 41 and 42). Similarly as a temporary building in Kaynashlı of traditional Turkish timber frame construction was being erected. In Degirmendere within the last year an exhibition hall was erected using traditional design and methodology (fig. 43). It was clearly meant to be a modern traditional structure which incorporates both the pattern of diagonal half-timber and the waddle and daub infill particular to Degirmendere.
