# Role of Railways in Building Resilient Against Natural Disaster-Lessons from Japan

Yoshitaka Motoda

Professor Emeritus Iwate Prefectural University Japan

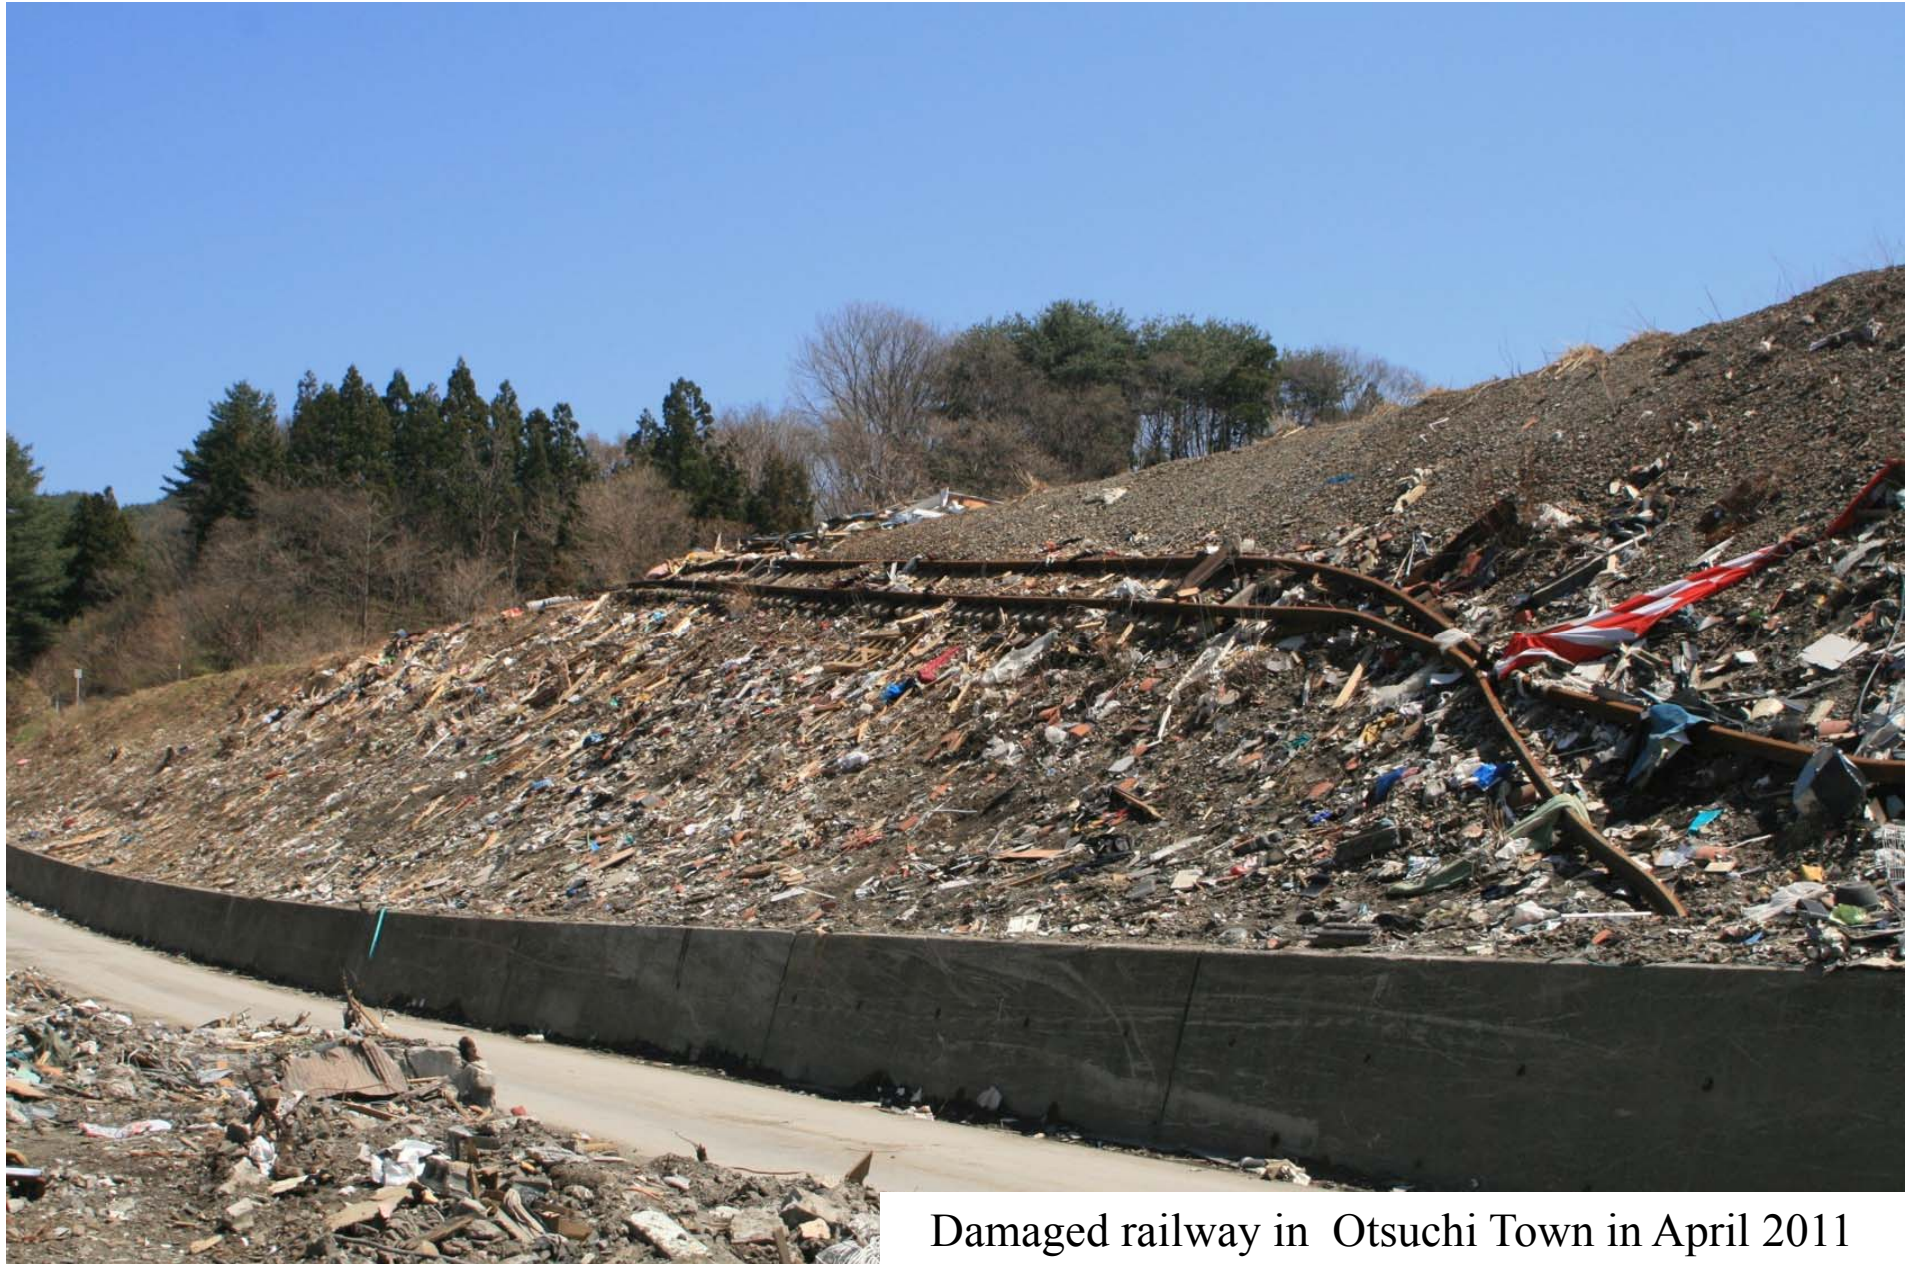
Damaged railway in Otsuchi Town in April 2011

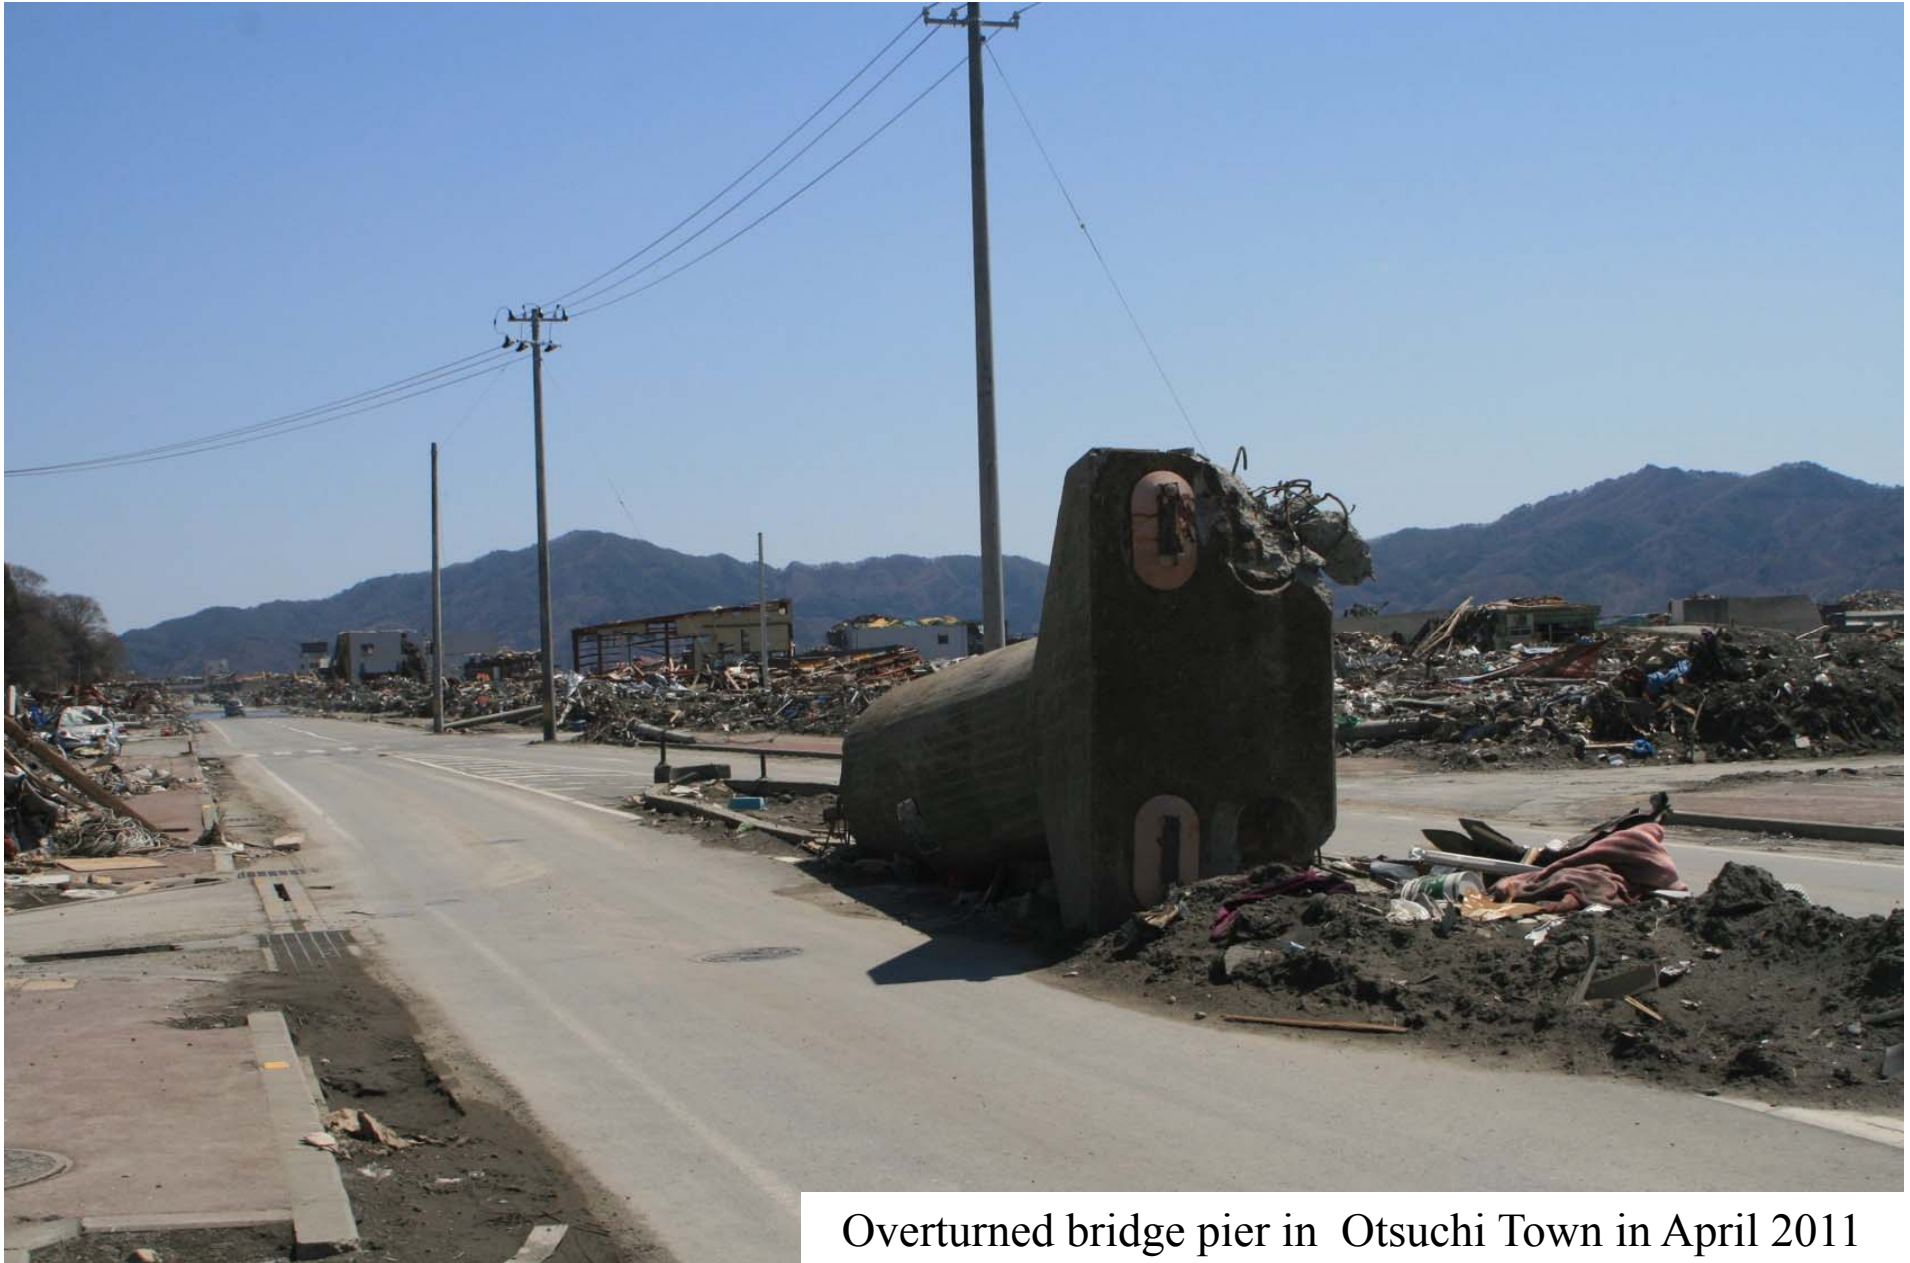
Overturned bridge pier in Otsuchi Town in April 2011

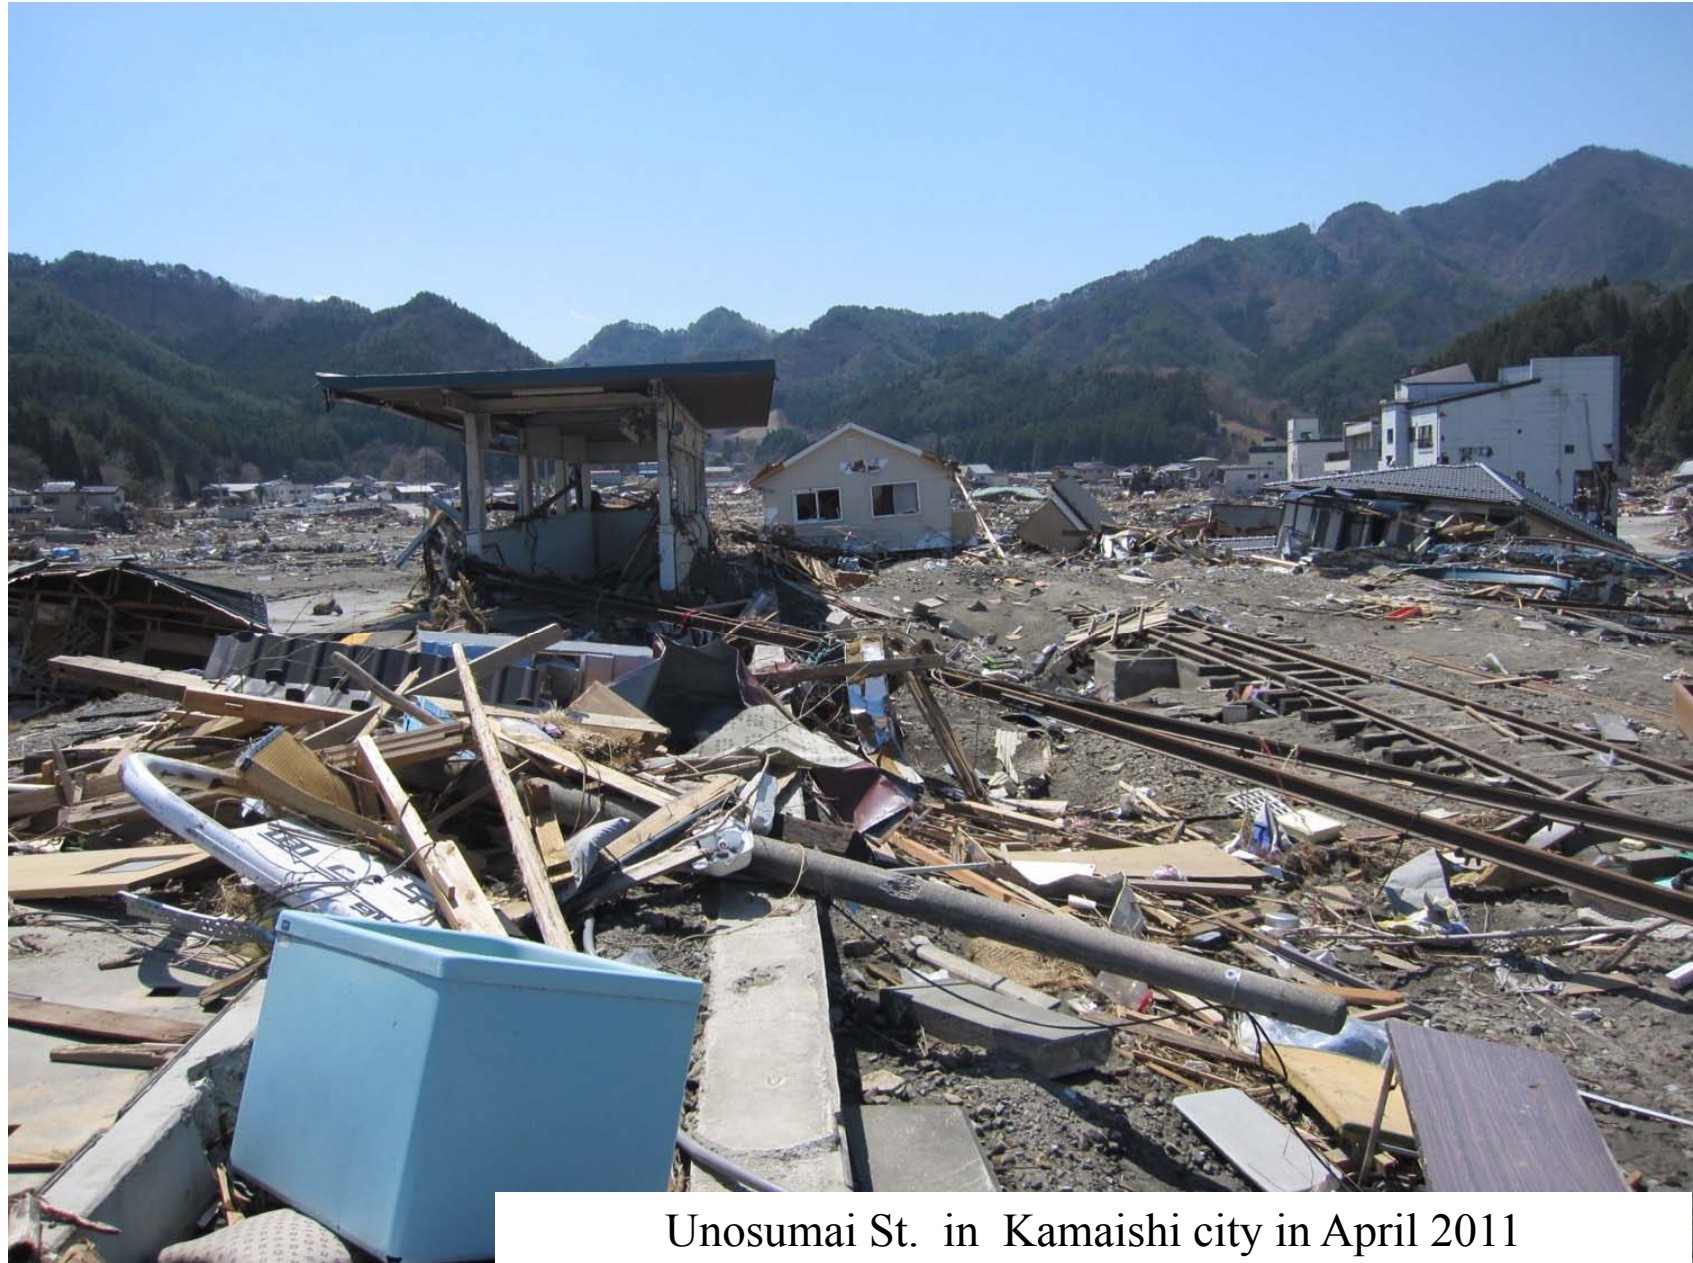
Unosumai St. in Kamaishi city in April 2011

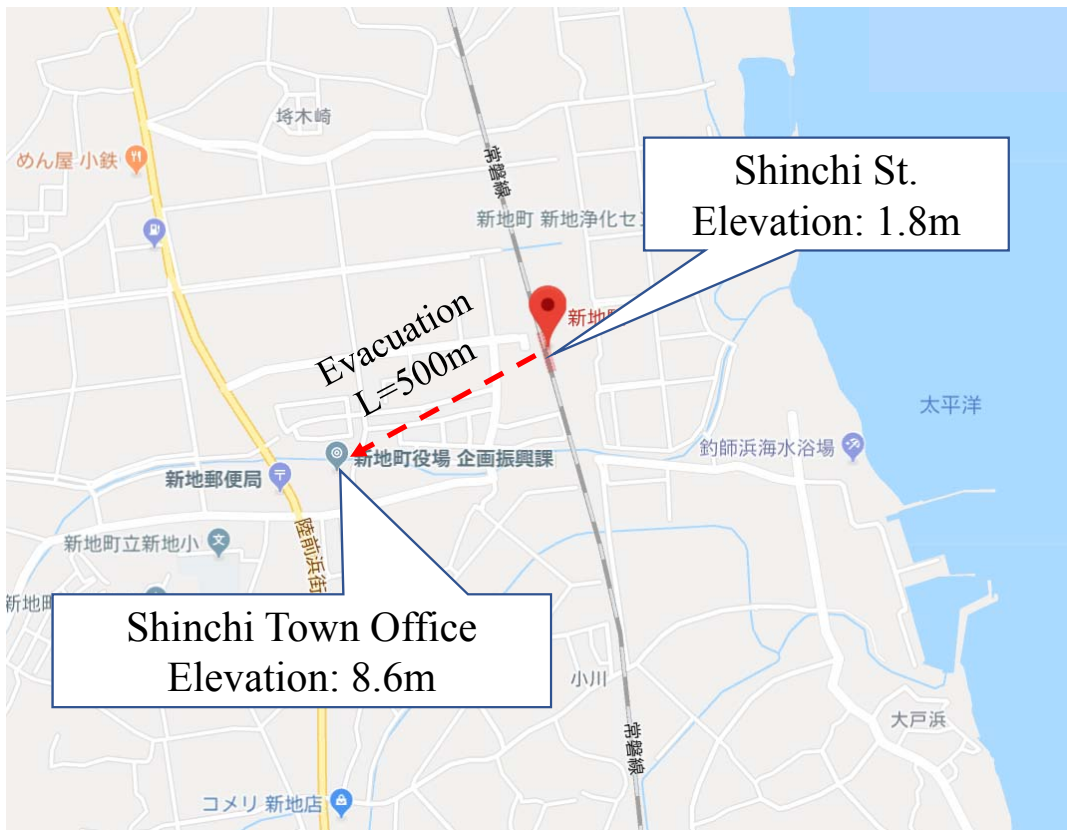
Shinchi Station after Tsunami attacked  
By Kahoku News Paper April 10, 2011

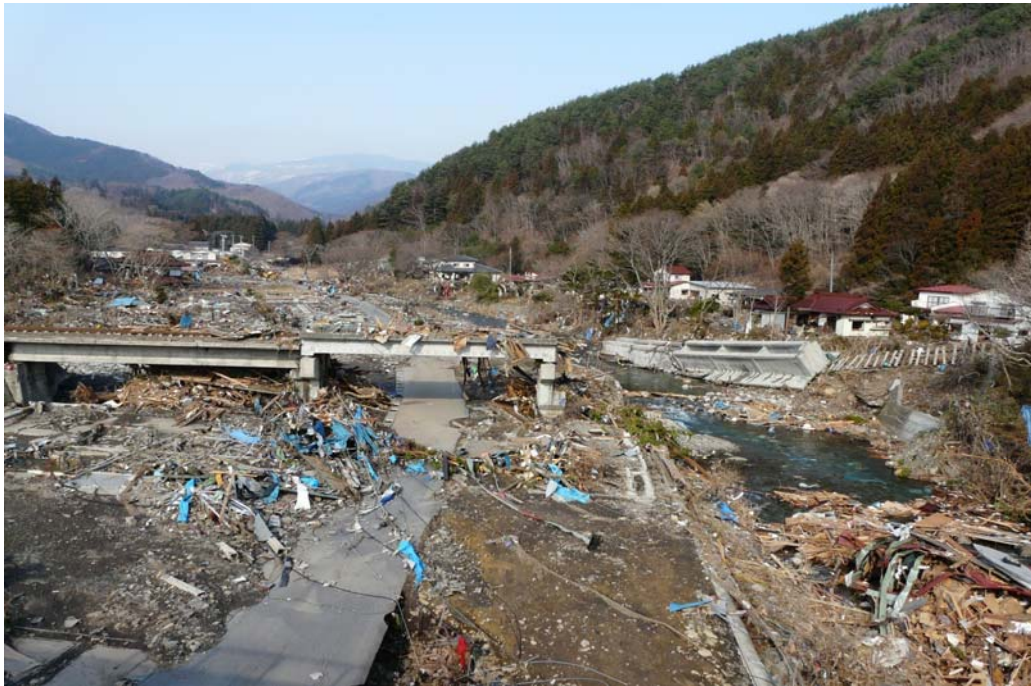
Washed away Bridge (South-Rias Line)

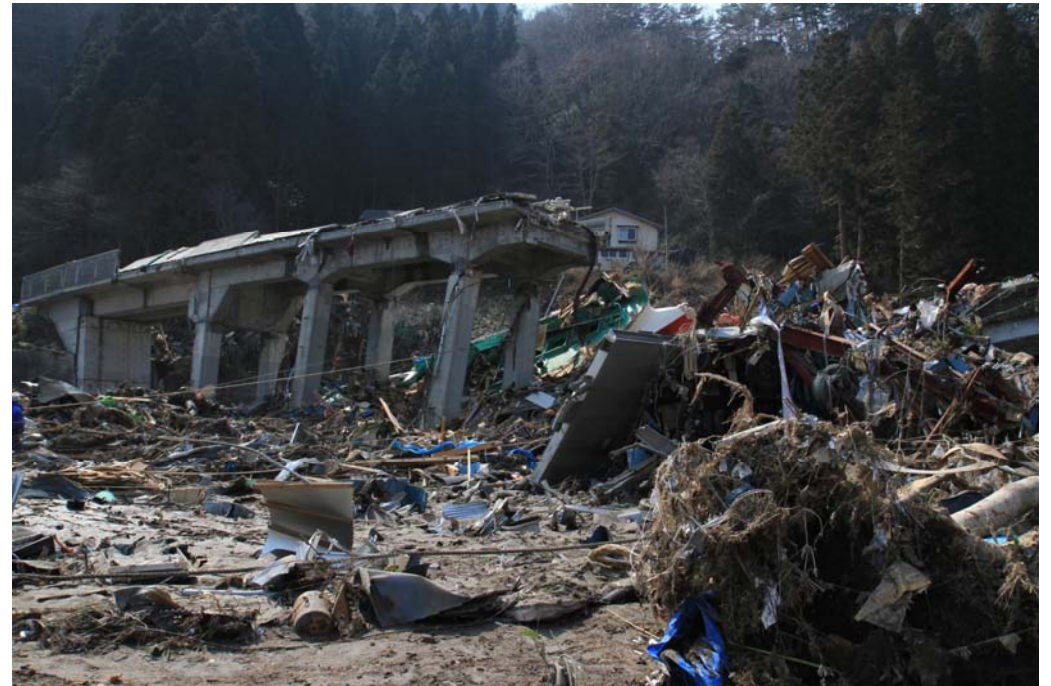
Wreckage of Bridge (North-Rias Line)

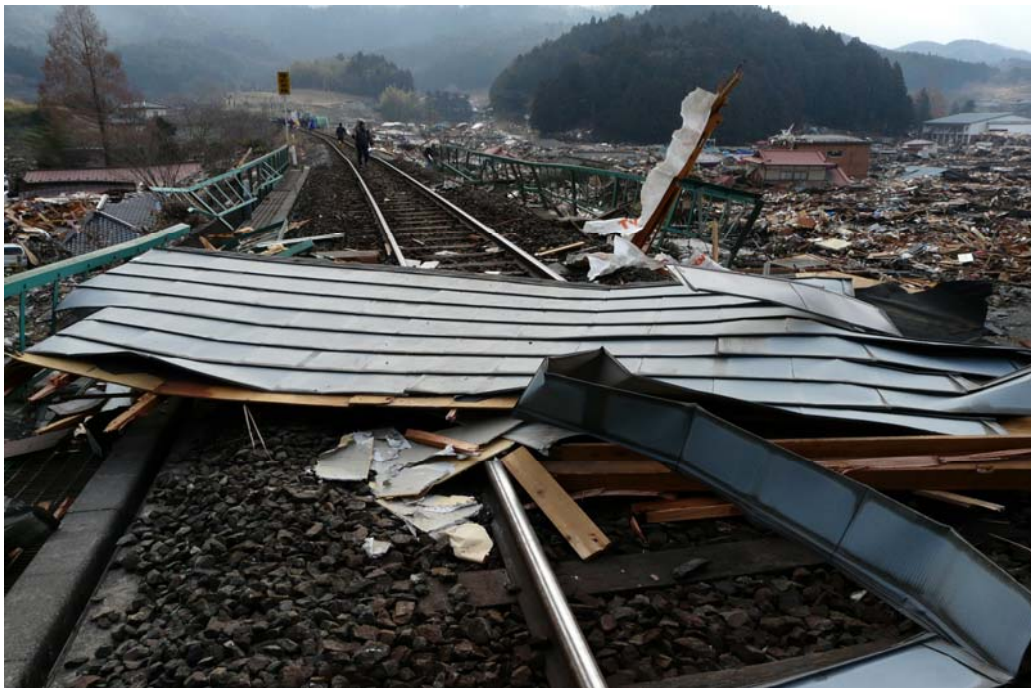
Debris on railway (South-Rias Line)

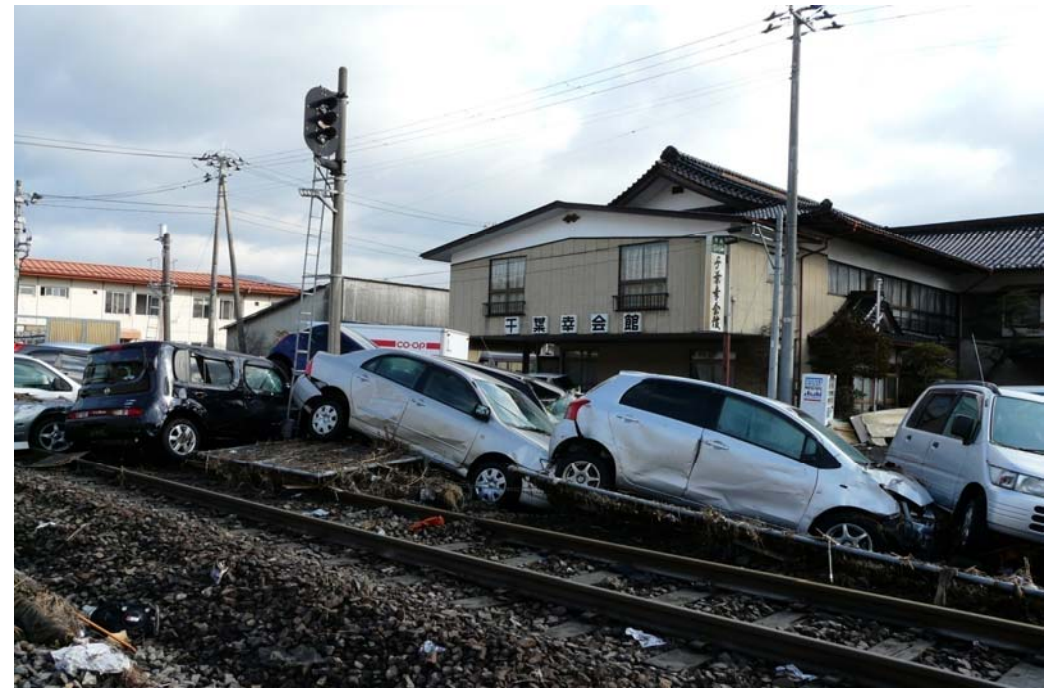
Drifted cars on railway (South-Rias Line)

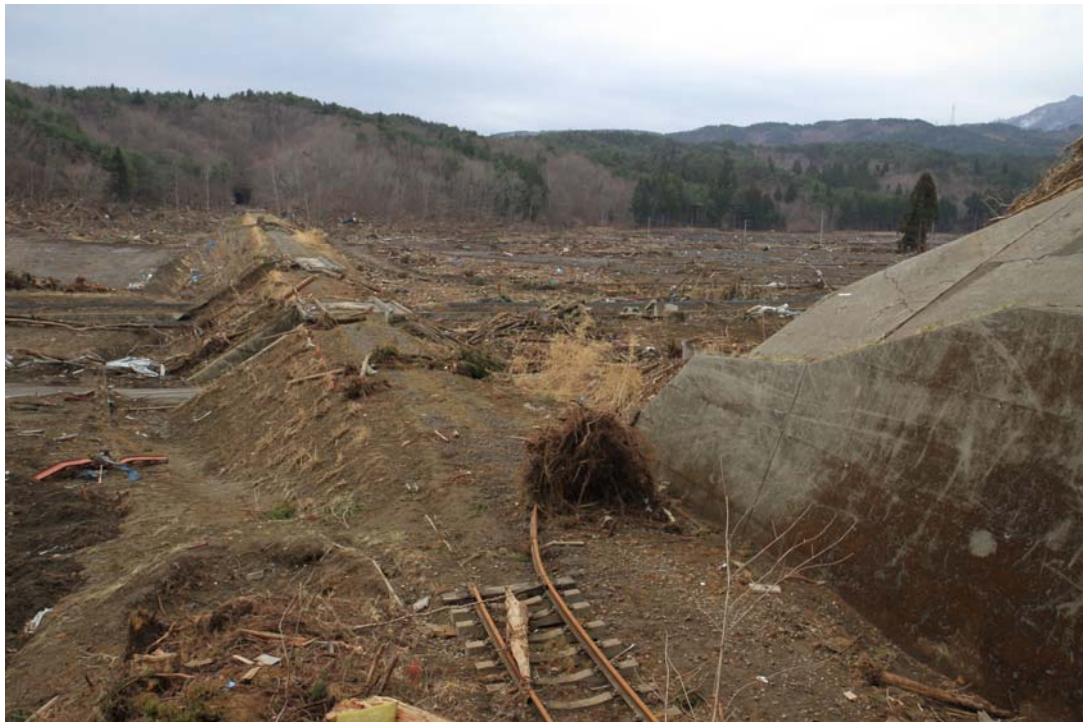
Just after the earthquake (North-Rias Line)

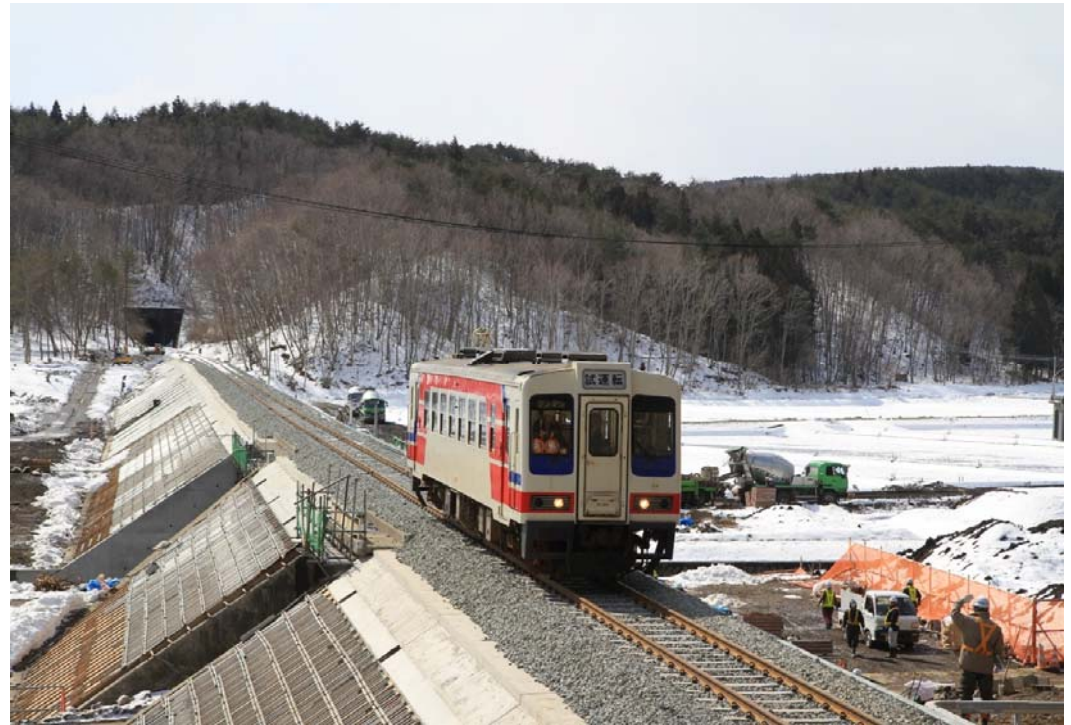
After the restoration (Same place)

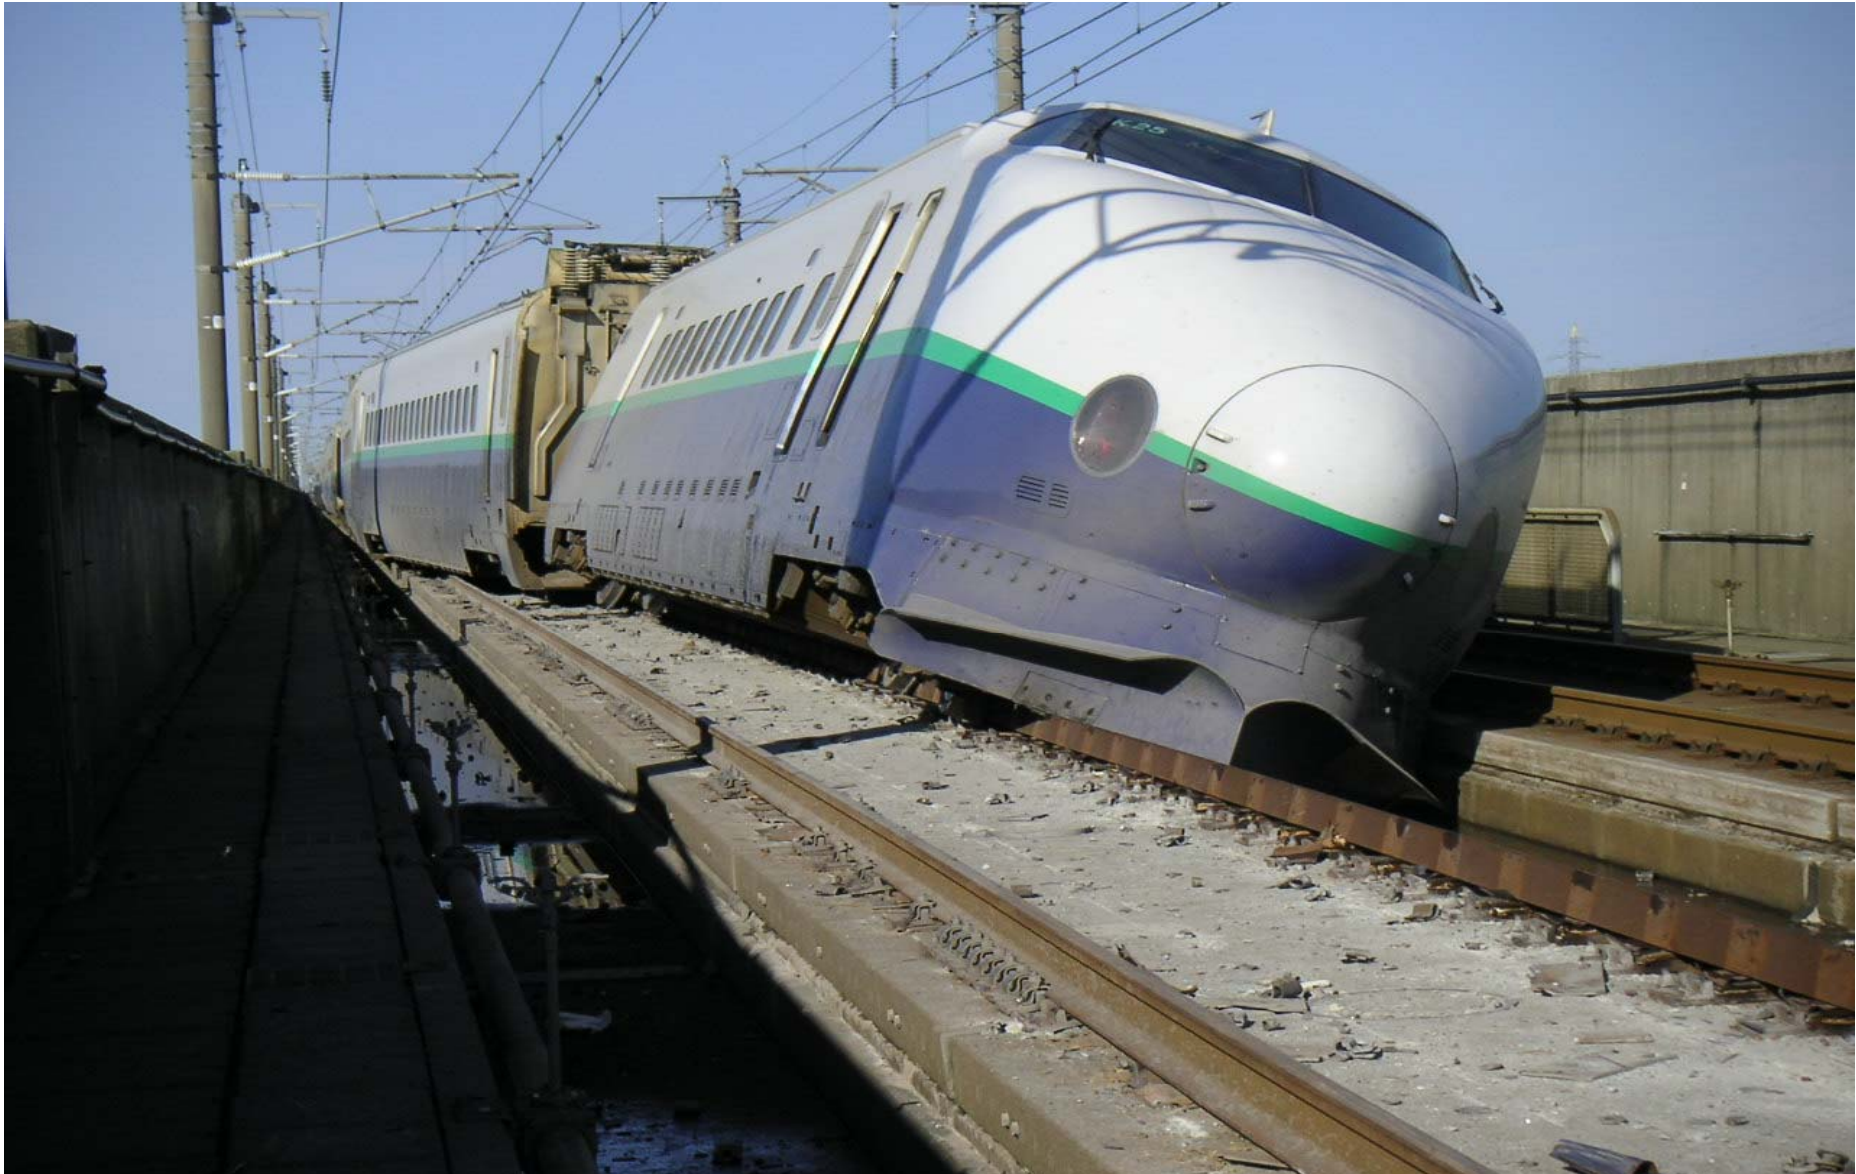
Derailed Shinkansen cars by Niigata Prefecture Chuetsu Earthquake in October 2004

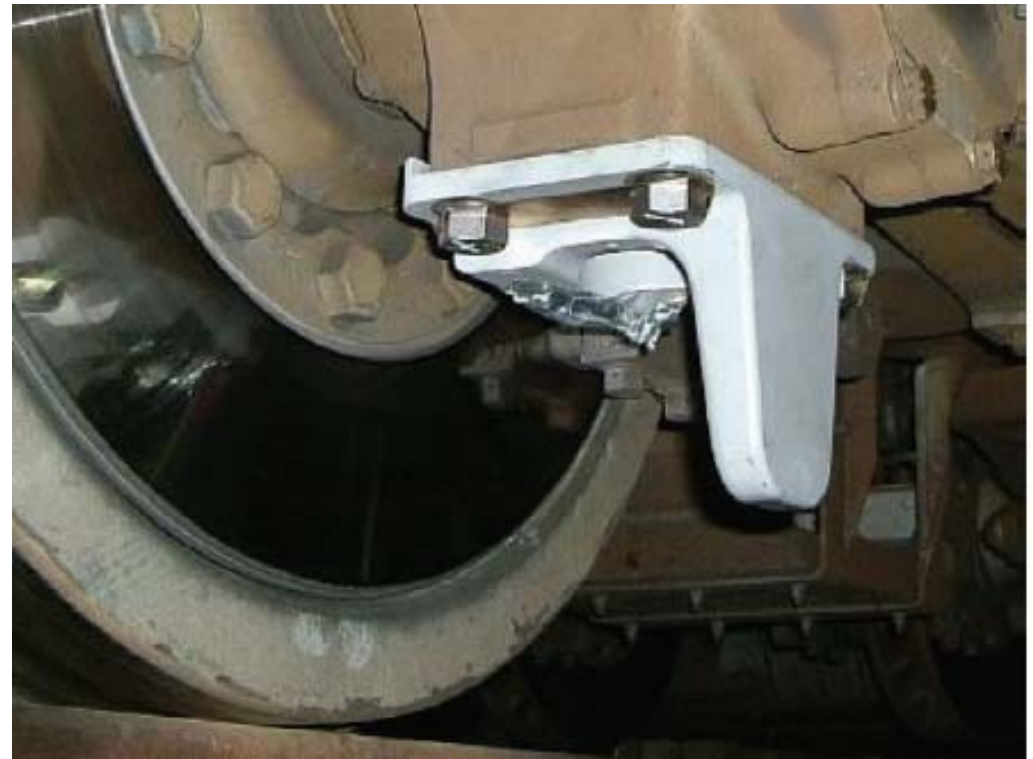
L-shaped guide to prevent deviation from rails

- The railways along Pacific Ocean coast were severely damaged by Tsunami
- However, it is noted that there were no injury or fatality on board train
- UrEDAS, Retrofitting of Bridge and Derailment device were effective for mitigating damage of high speed train system
- Bus Rapid Transit system was first introduced in Japan as a substitute of train with low passenger needs

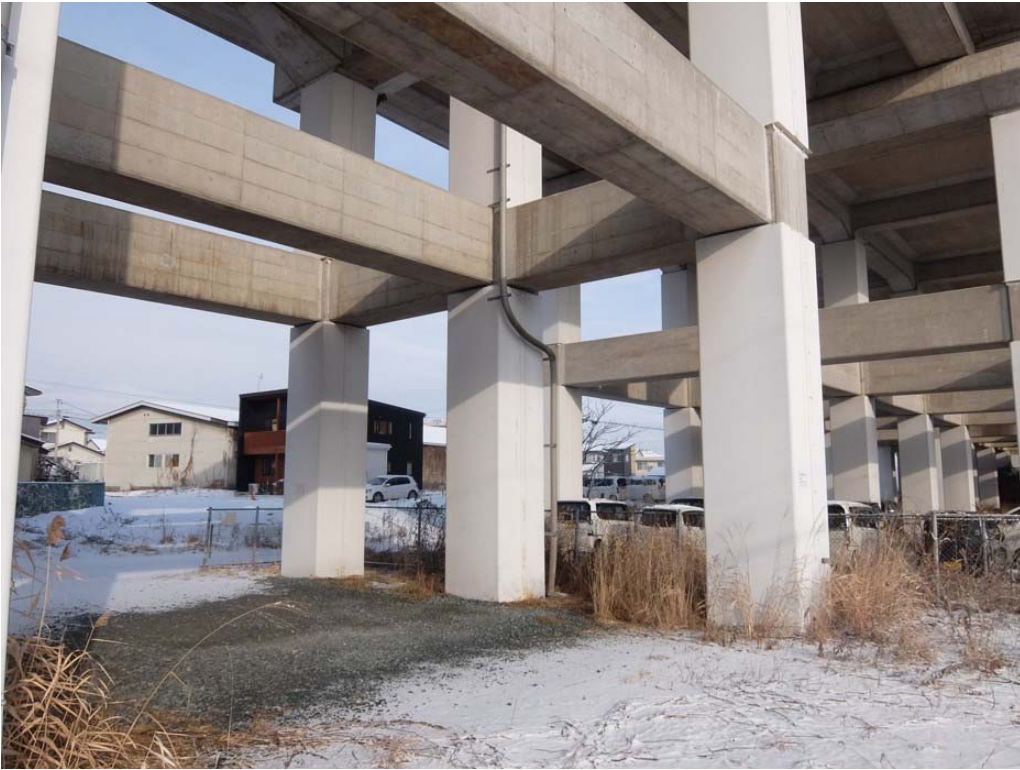
Steel Jacketing (Tohoku Shinkansen, Morioka city)

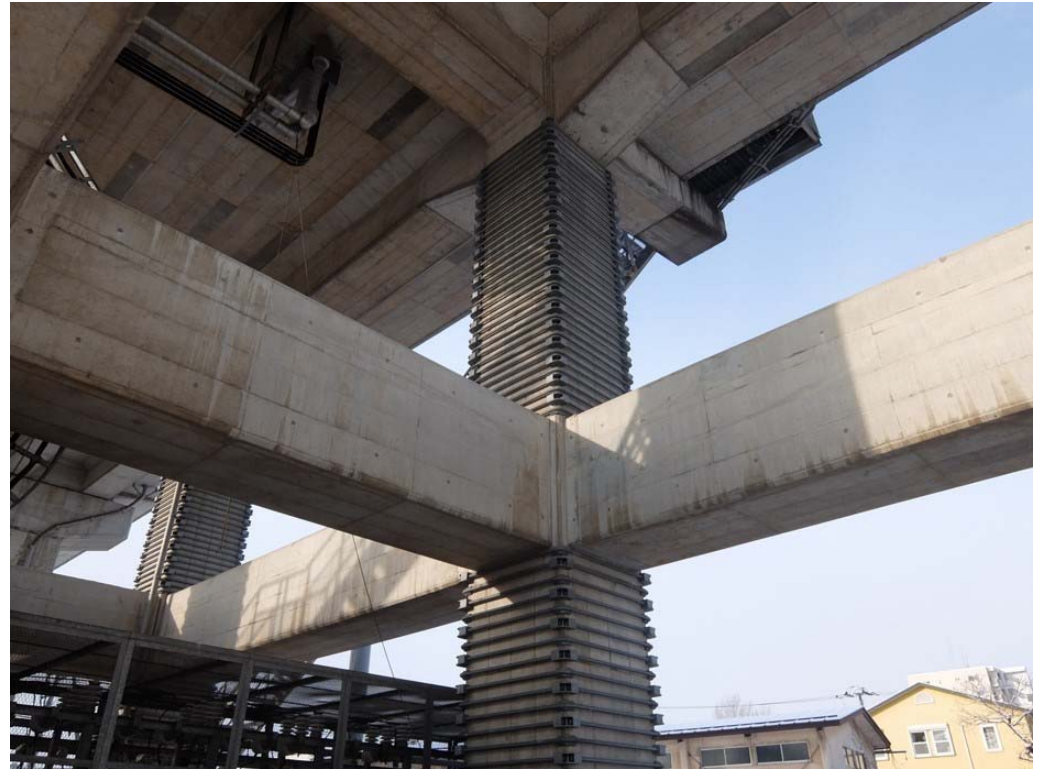
Rib-bar retrofit (Tohoku Shinkansen, Morioka city)
