# Lessons learned from the Great East Japan Earthquake

-Concerning road network system-

April 2013 Bali Indonesia

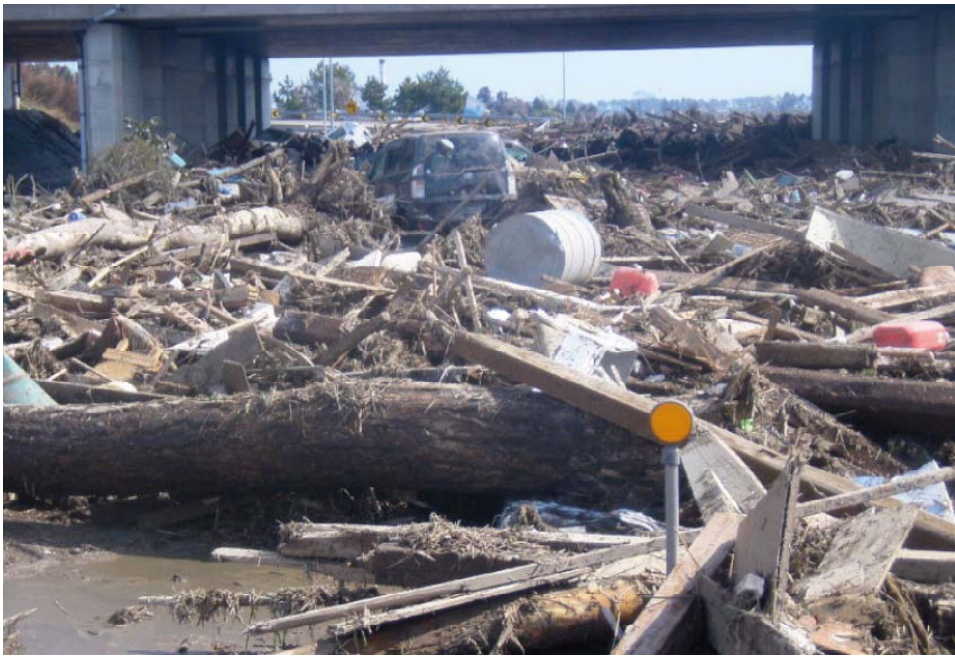
Wakabayashi Junction, Sendai Tobu (East)  
Road

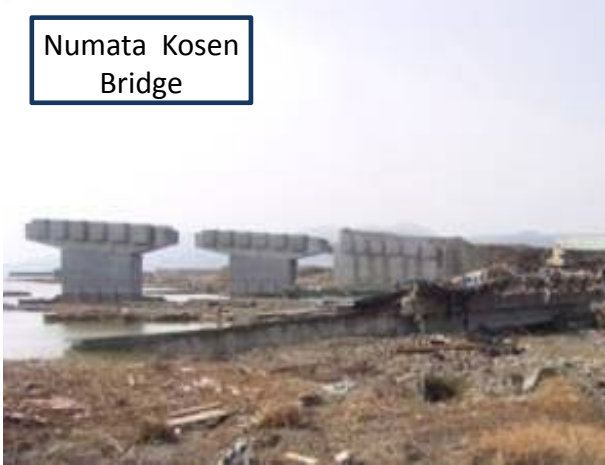
Numata Kosen  
Bridge

- On the roads directly managed by the national government, the tsunami washed away five bridges.

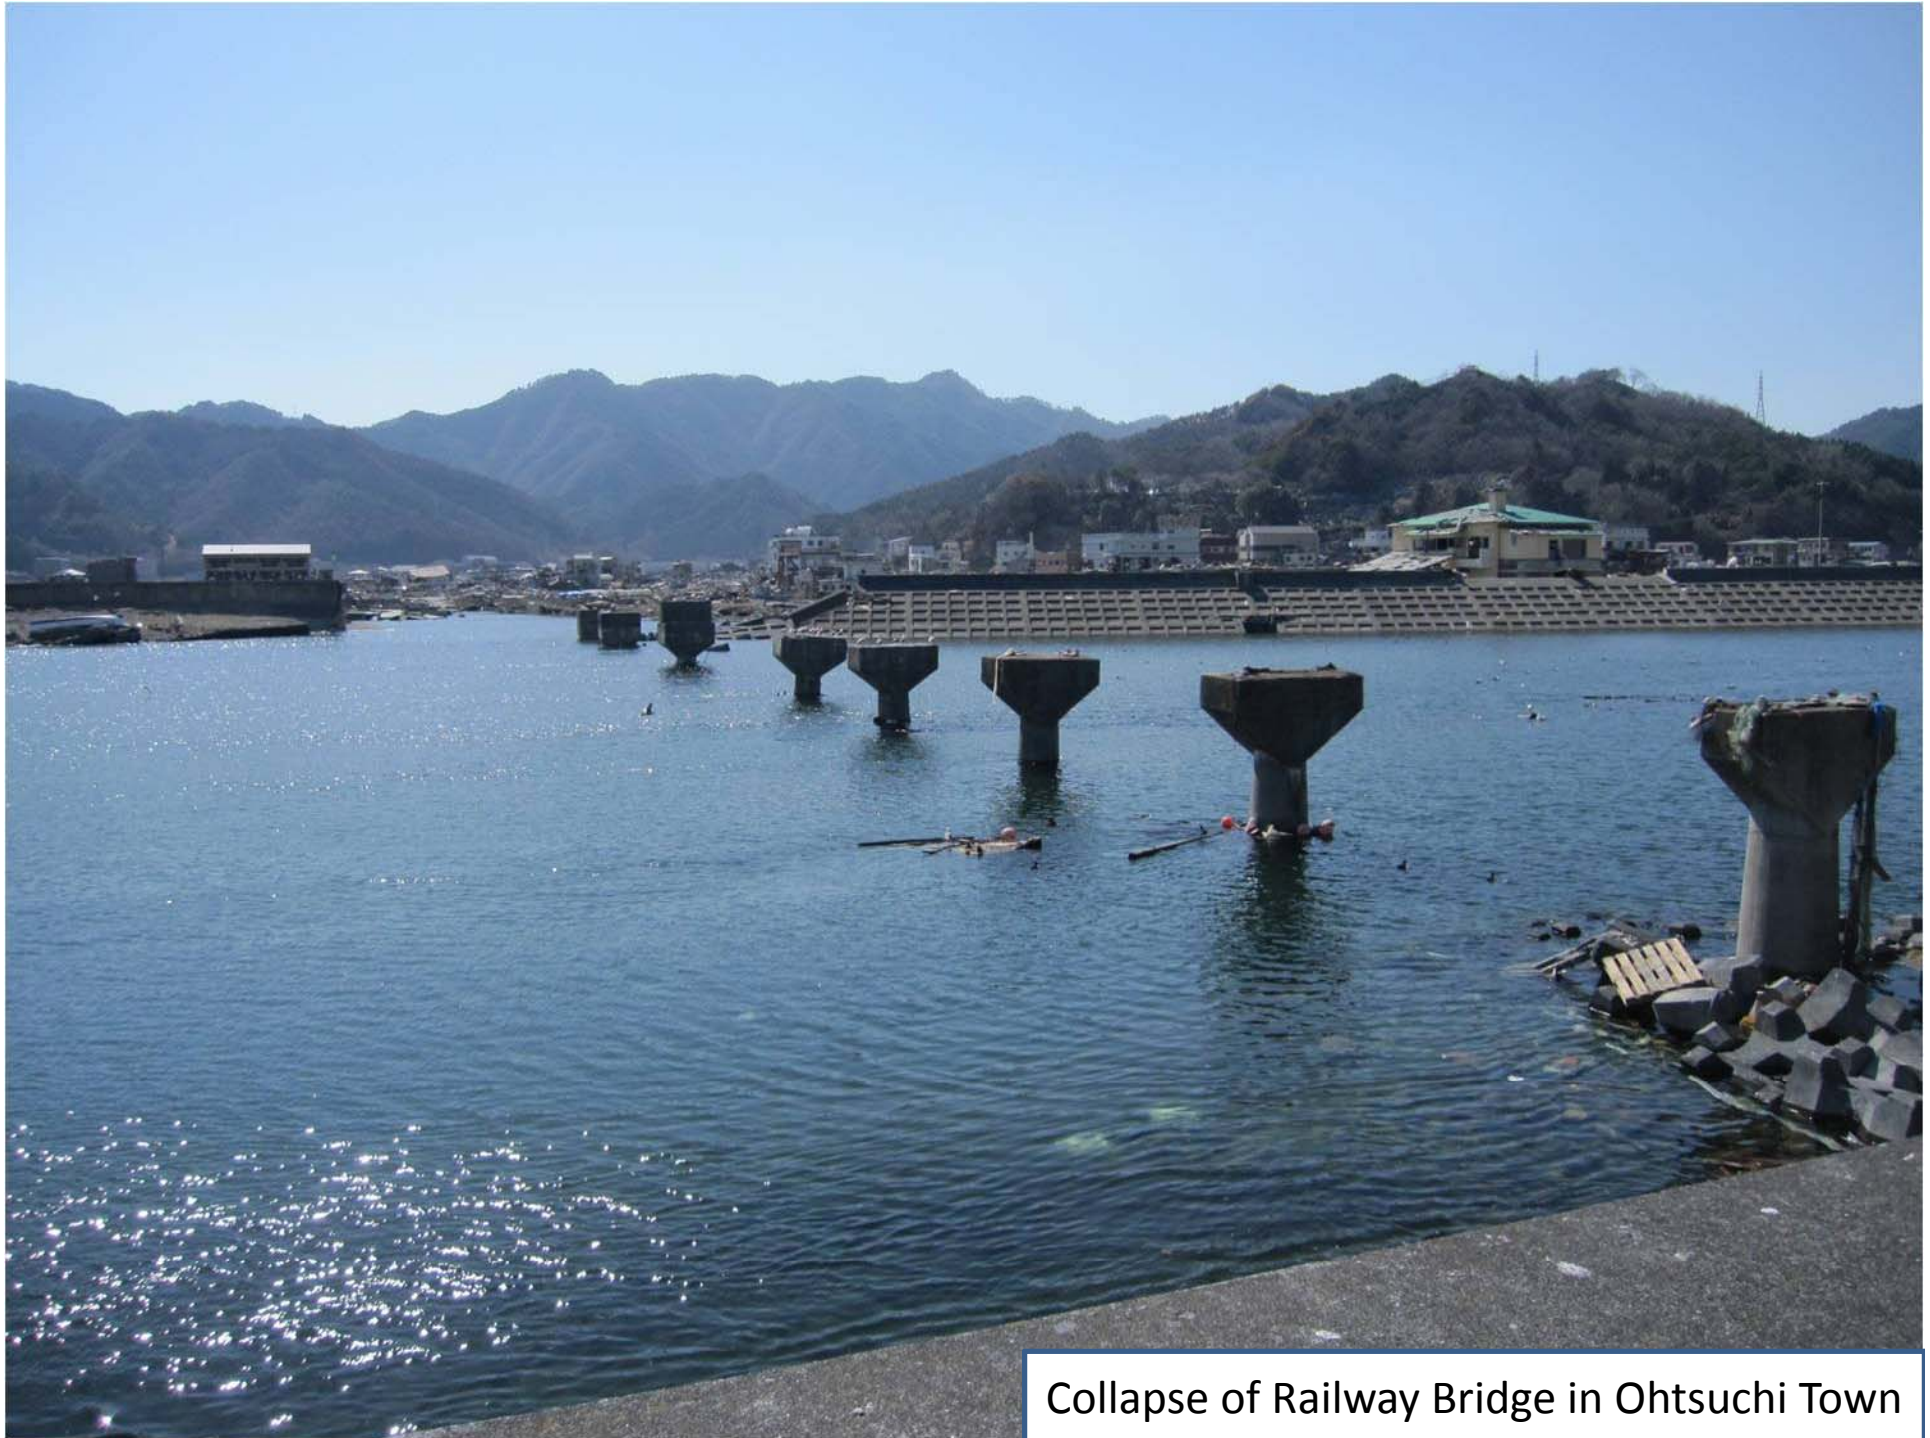
Collapse of Railway Bridge in Ohtsuchi Town

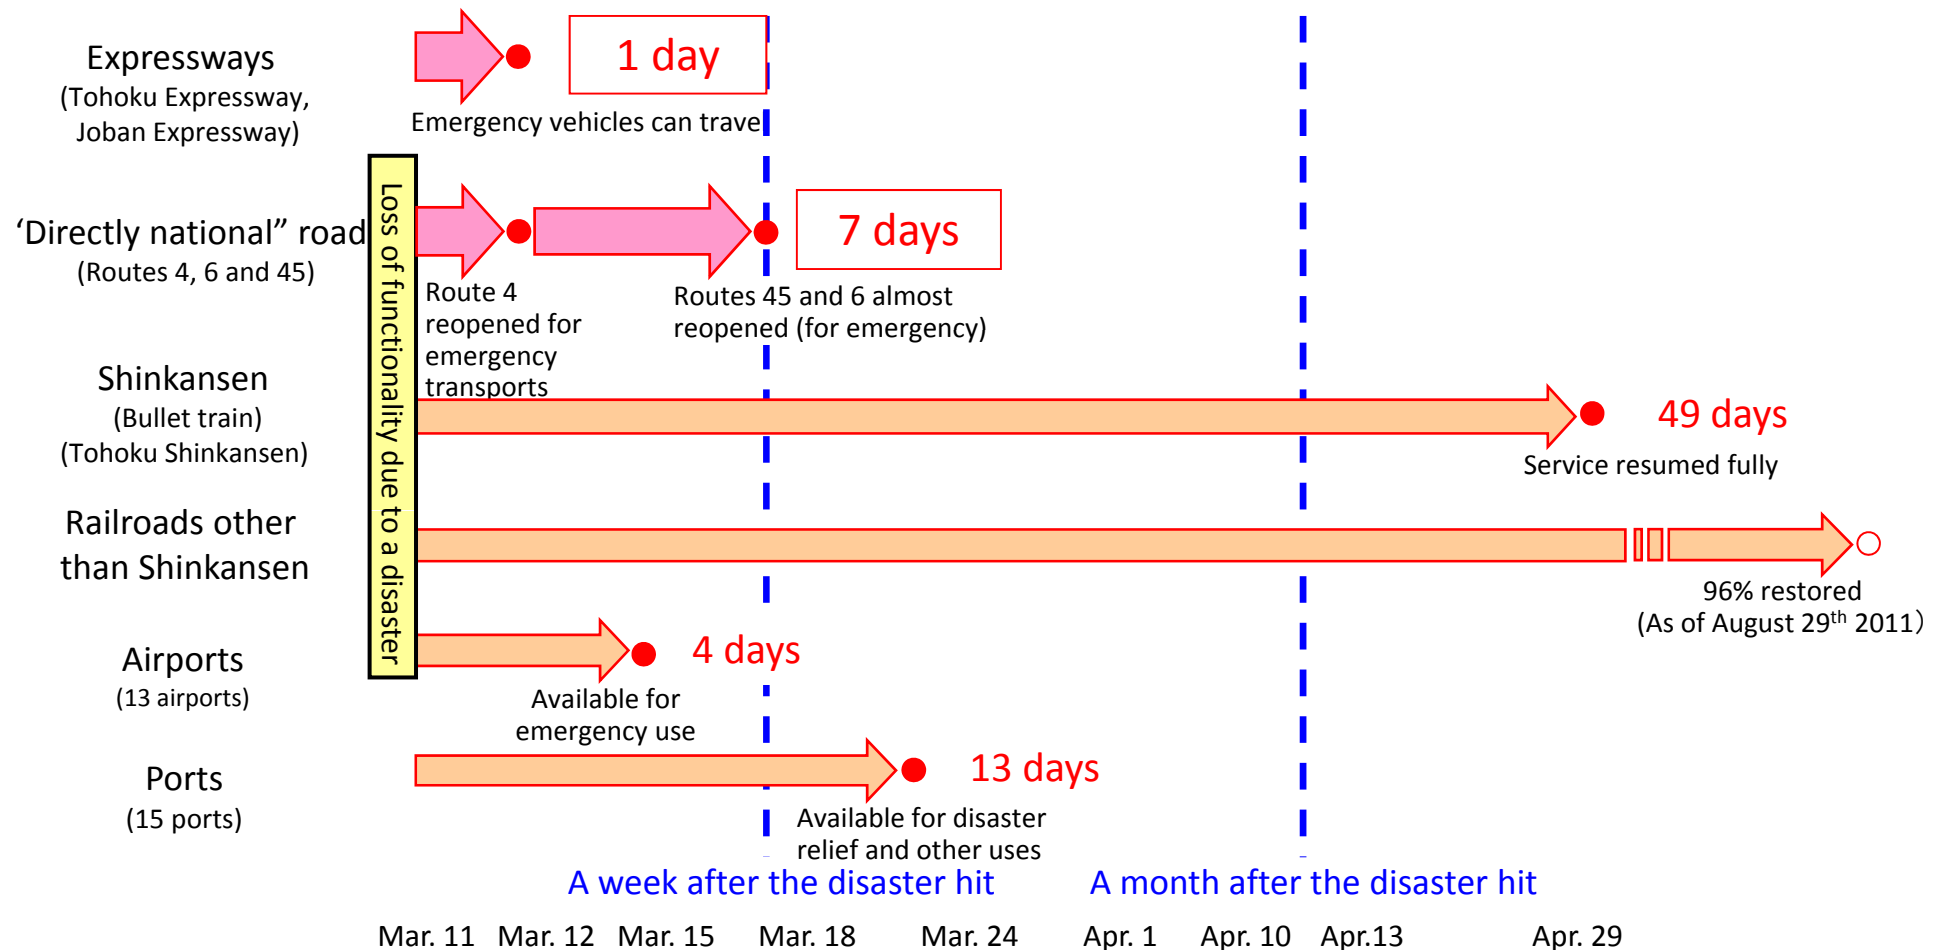
# Time length until a damaged road was reopened for emergency use

- Among the different types of transport infrastructure, roads can recover for emergency use sooner than the others.

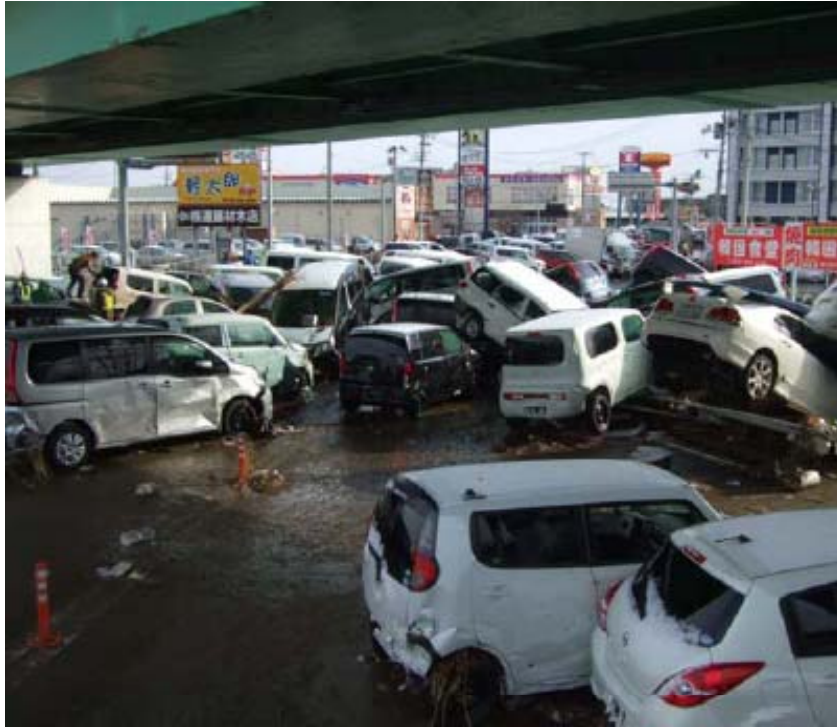
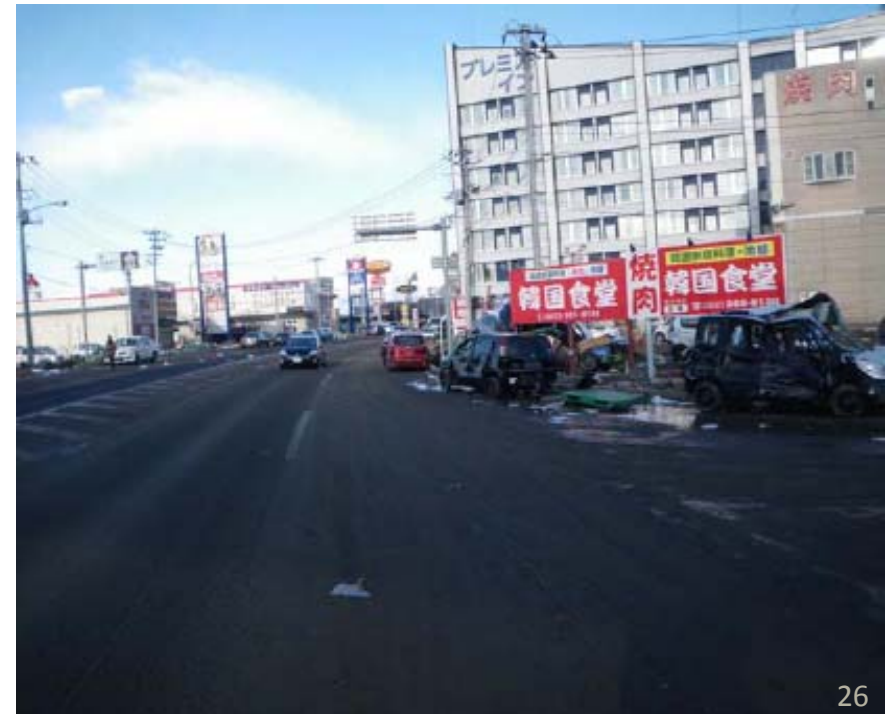
Before and after reopening work (Tagajo, Miyagi Pref.)

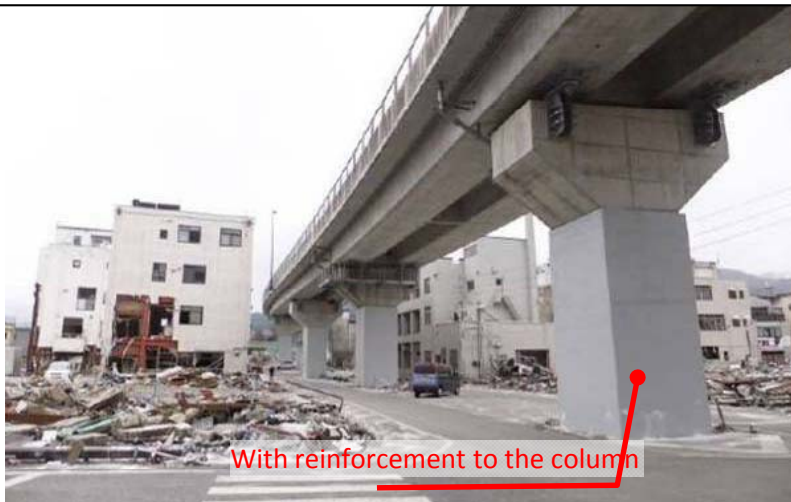
Route 45 (Observed intensity: 6-)

With reinforcement to the column

[Reinforced with a steel plate wrap-up]  
Unaffected by the earthquake

- Learning from the road damages caused by the Hanshin-Awaji Earthquake, measures of earthquake resistance improvement were applied. These measures should prevent fatal damages like a bridge collapse and let SDF, police, fire department, and other rescue and recovery teams to travel on such roads for early rescue and recovery work.

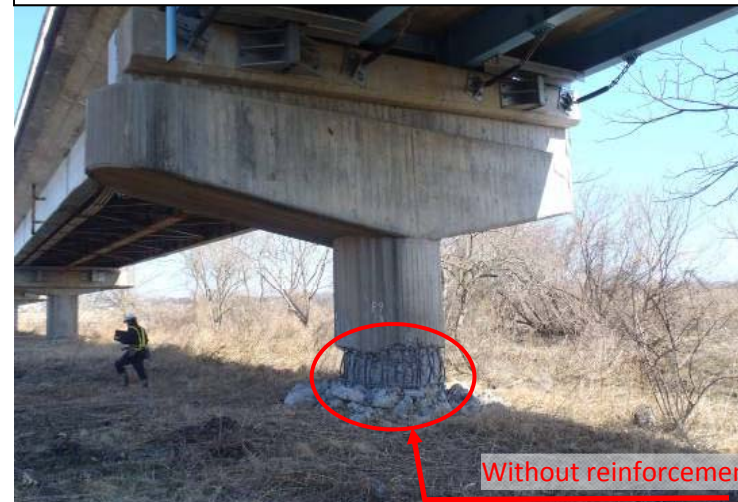
Prefectural road (Observed intensity: 5-)

Without reinforcement

[Without reinforcement]  
The earthquake damaged columns.

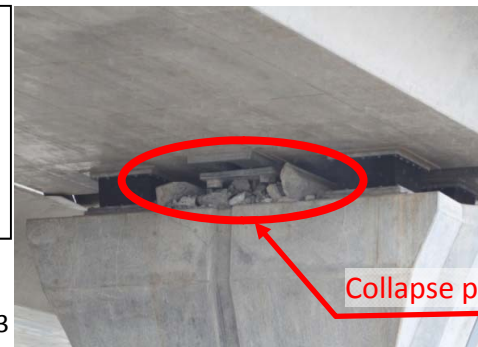
- Collapse preventions worked.
  - Part of such preventions were damaged. (middle of the photo)
  - The rubber shoe supporting the beam (the black portion) remained sound.

Collapse prevention

Partial damage to a prevention ►

Azuma Elevated Road, part of Fukushima Nishi (west) segment, Route 13

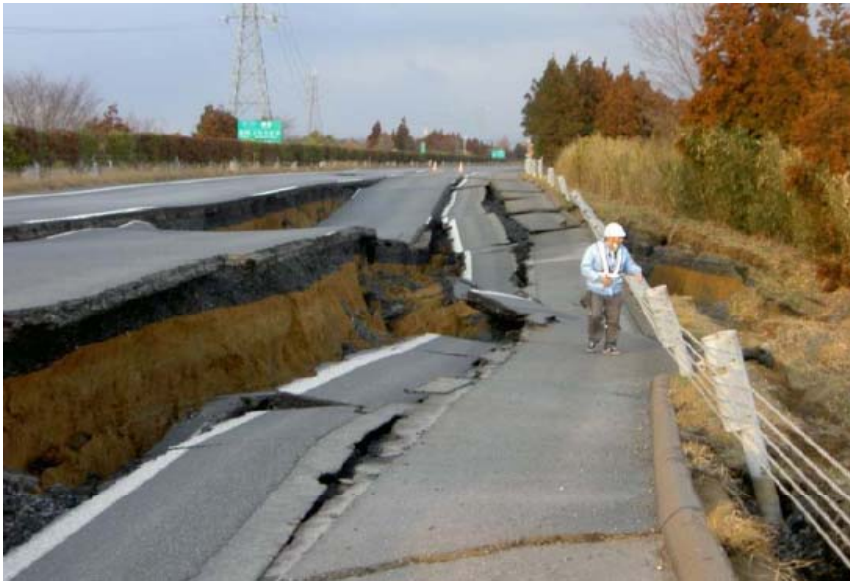
○ Example of Joban Expressway (Between Mito and Naka Interchanges)

Soon after the earthquake, on March 11, 2011

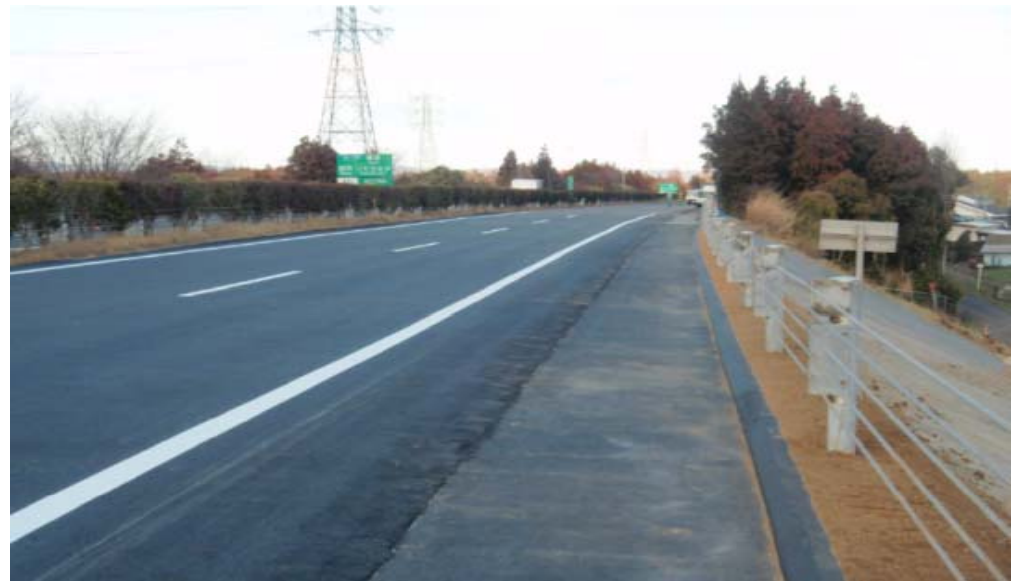
Fully restored, on March 17, 2011

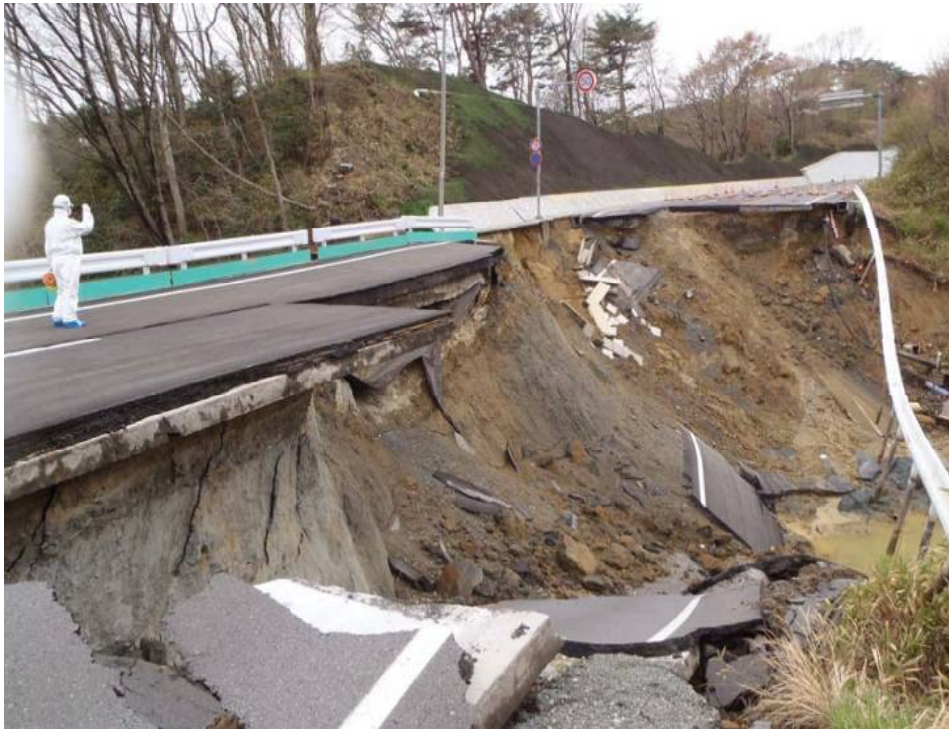
○ Example from Route 6, in Kamikoriyama, Tomioka-machi, Fukushima Pref.

Soon after the earthquake, on March 11, 2011

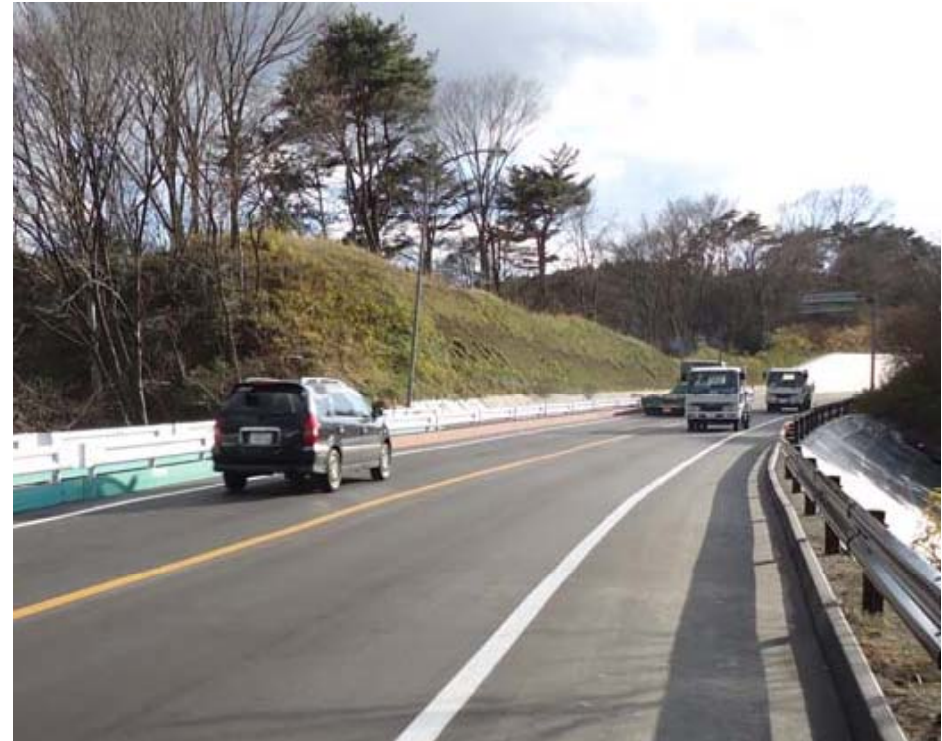
Fully restored, on December 26, 2011

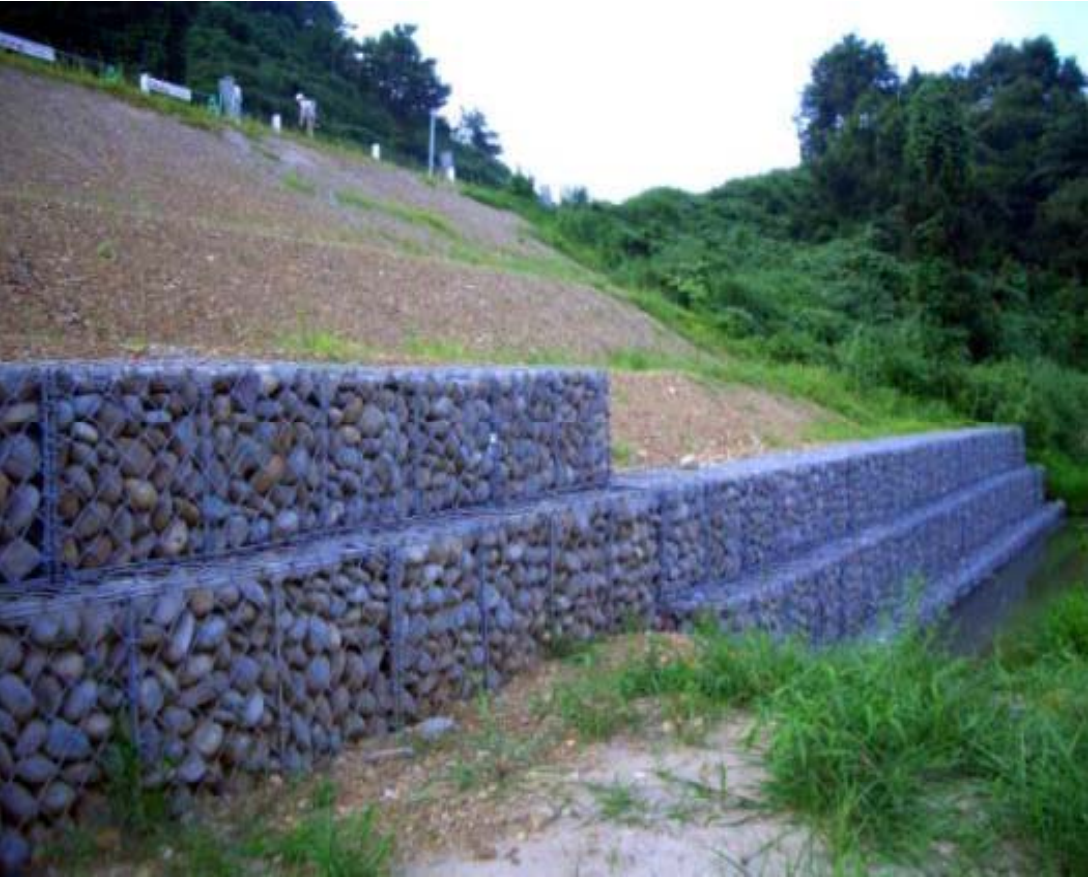
Gabions installed

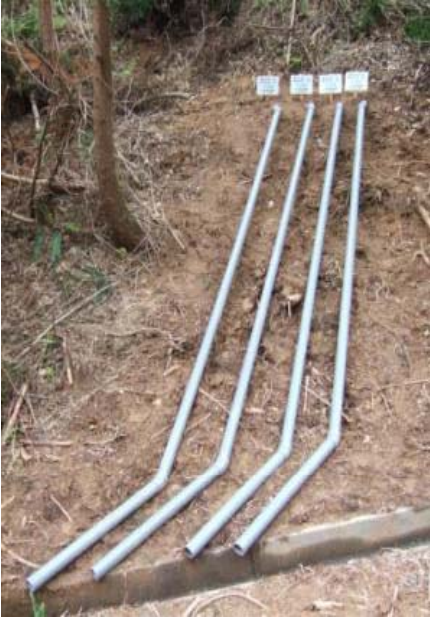
Drainage pipes installed

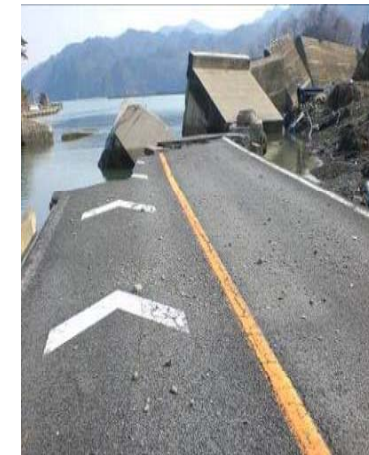
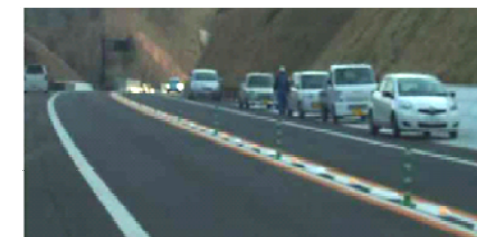
- Sanriku Juukan (longitudinal) Road, which runs along the Pacific Coast, was designed to avoid tsunami, based on experiences. It successfully avoided tsunami damages.
- An important lesson was road infrastructure must be planned and built to avoid tsunami.

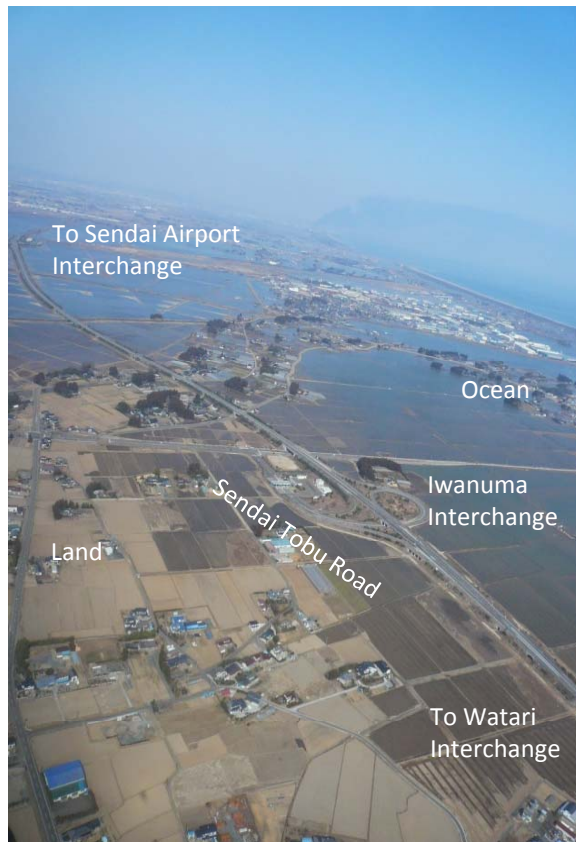
- In Sendai Plain, where the end of the tsunami invaded 4km inland, Sendai Tobu (East) Road, whose embankment structure was 7 to 10m above the surrounding ground, provided a shelter to some 230 citizens.
- The embankment of Sendai Tobu Road also functioned as a surge barrier, which alleviated the inflow of the tsunami into the inland downtown.

Inundation around Sendai Tobu Road
