# Bridge Inspection and Bridge Deck Renewal Projects in Japanese Expressways

**Yoshinori MIKURA**

West Nippon Expressway Company Limited (NEXCO- West)

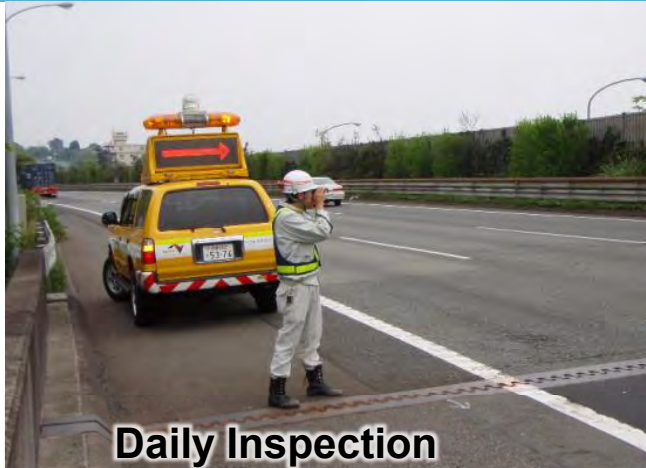
**Daily Inspection**

(Visually while driving, (getting off as needed)) (Annually: visual inspection from the ground)

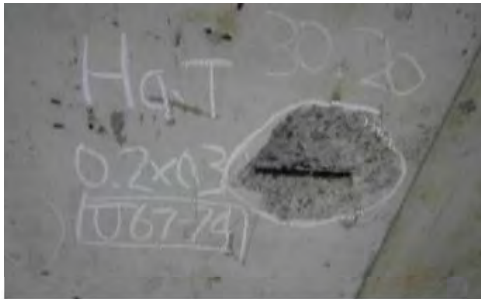
(e.g.) Target defects

- ✓ Automatic photographing & stitching pictures
- ✓ Automatic crack & efflorescence detection
- ✓ Easy to make inspection record

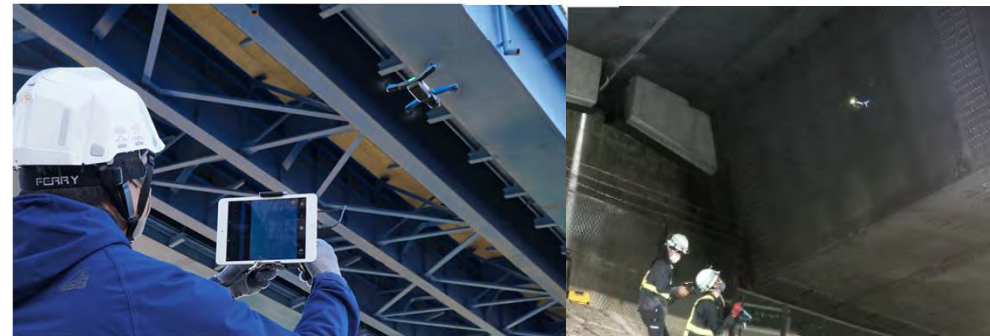
UAV

- ✓ Apply for bridges that difficult to approach
- ✓ Can reduce cost and improve safety.

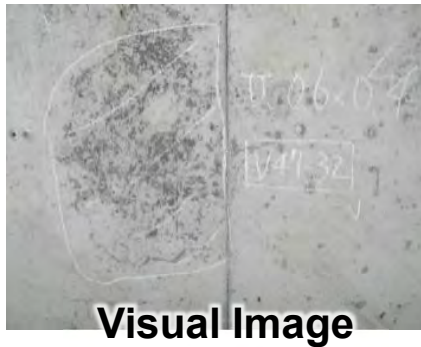
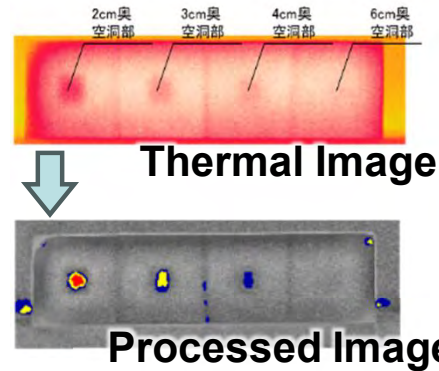
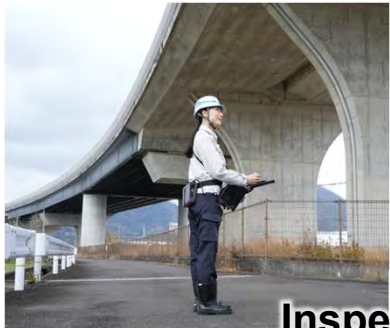
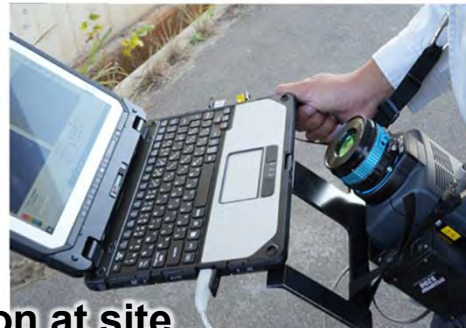
## Infrared Thermography

- ✓ Detect invisible delamination
- ✓ Prevent third party accident by fallen concrete

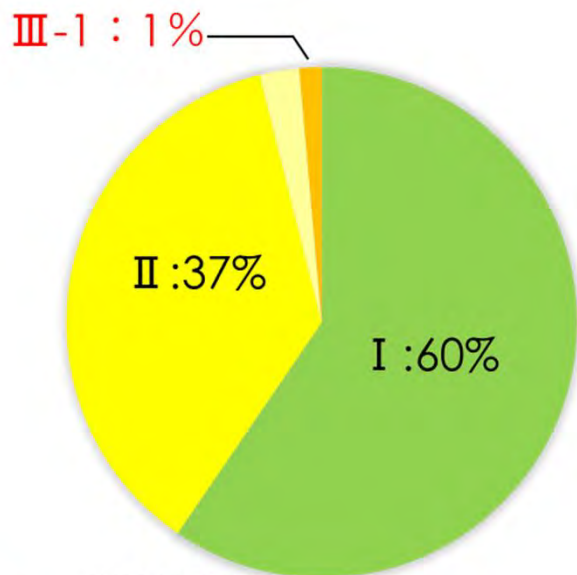
## Bridge Condition (Inspected in 2019 - 2023)

IV	Severe
III-2	Poor -2
III-1	Poor -1
II-2	Fair -2
II-1	Fair -1
I	Good

- ❑ The percentage of bridges with CS-II and CS-III are steadily increasing.
- ❑ By individual element, the defects in girder ends are increasing due to exposure to water.

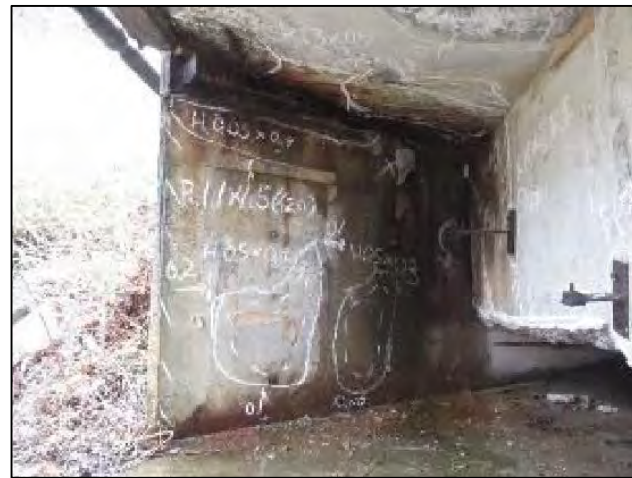
- ❑ de-icing salts for winter maintenance are highly influential to the bridge deterioration.
- ❑ Distributed de-icing salts goes through the expansion joints onto girder ends and bearing

Girder ends and Bearings (46% of CS-III)

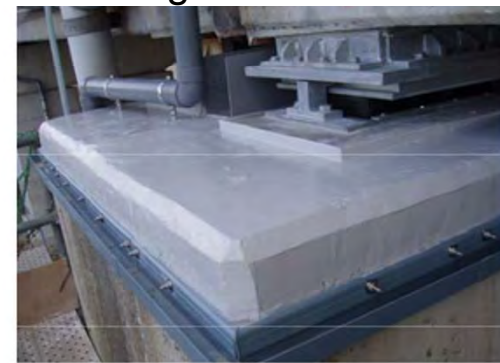
- ❑ Rep the Bearing
- ❑ Coating on Concrete Surface

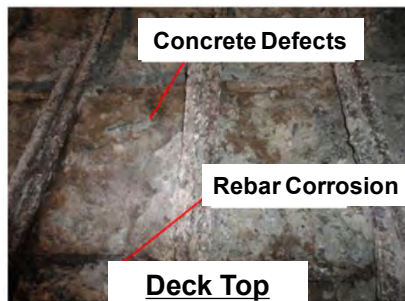
Example 1

- ❑ Serious issues due to aging, application of de-icing salts, increased volume of traffic including over-loaded trucks.
- ❑ Older bridges were constructed with outdated design and construction standards, and these caused significant deterioration.

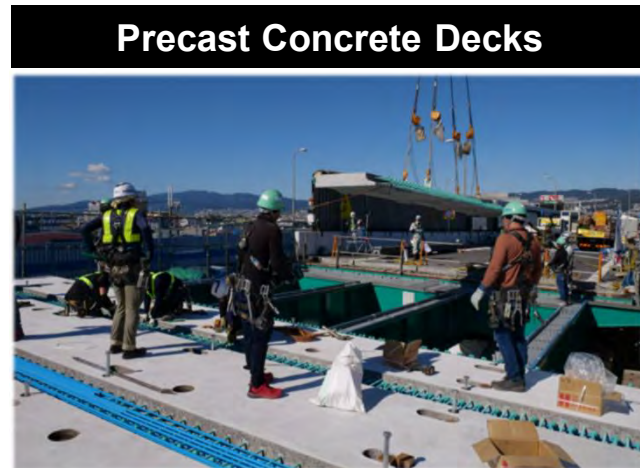
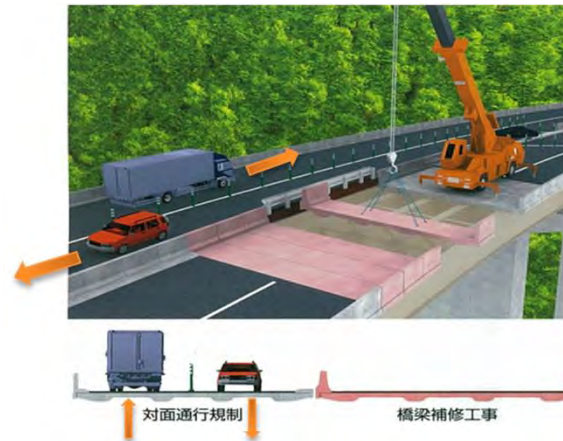
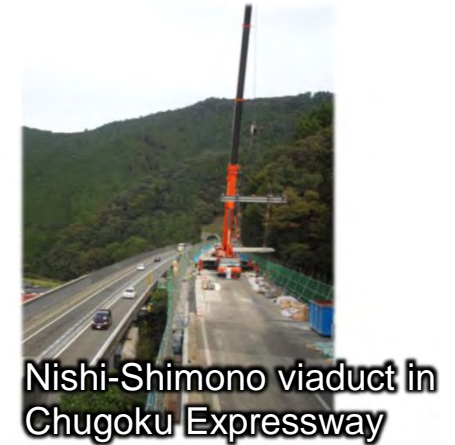
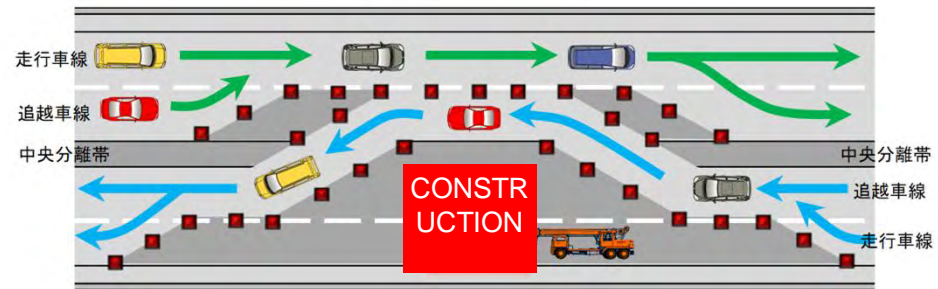
# Typical Method to Replace RC decks

- ❑ To reduce construction time onsite, Precast Concrete Decks are being used instead of cast-in-place.
- ❑ 4-lane roads are consolidated to 2-lanes on each side of the expressway with a two-way traffic operation. (In lower traffic volume areas)
- ❑ In the secured work zone, the existing deck is removed and replaced with the precast decks.

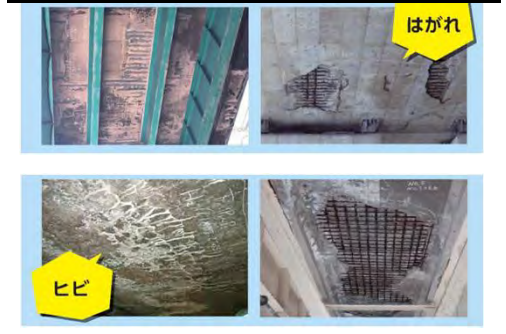
**Bridge Deterioration**

- ❑ This section of highway was constructed just before the 1970 Osaka Expo (about 50 years old)
- ❑ This area has been urbanized in 50 years, and our bridges became deteriorated.

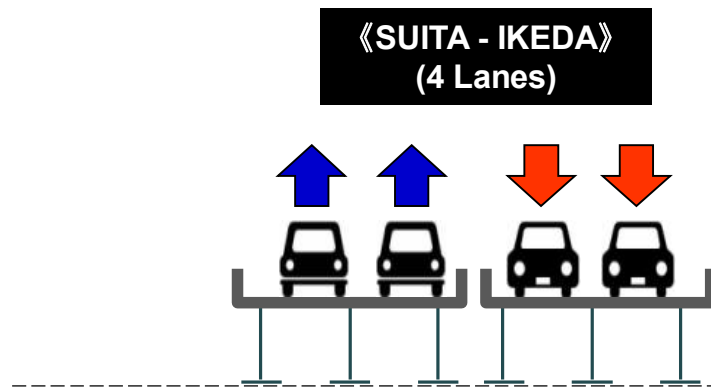
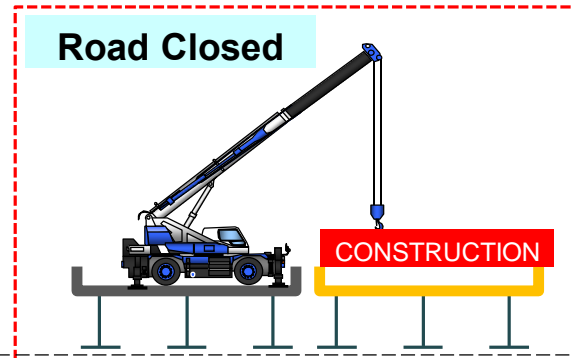
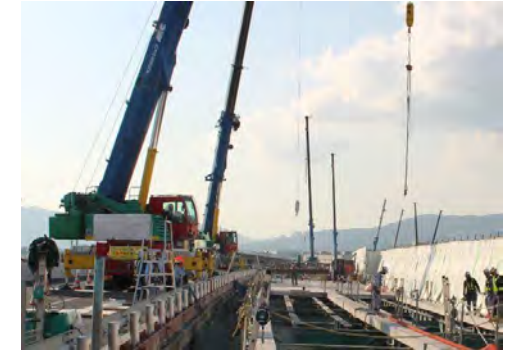
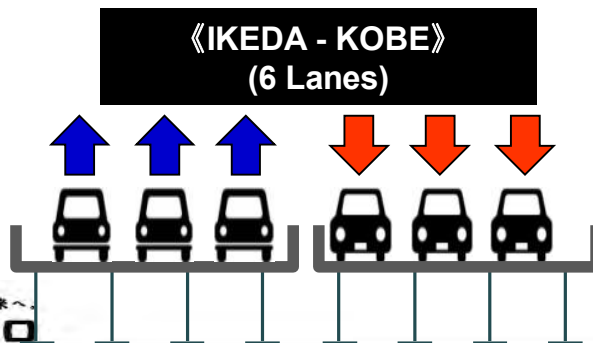
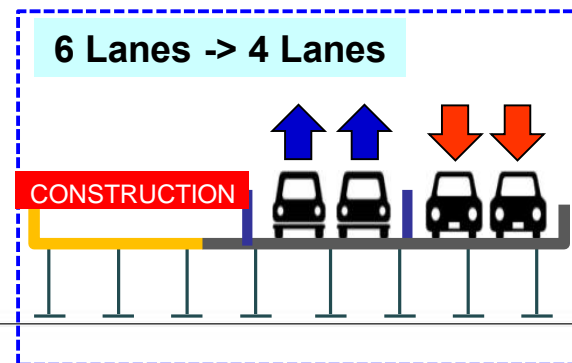
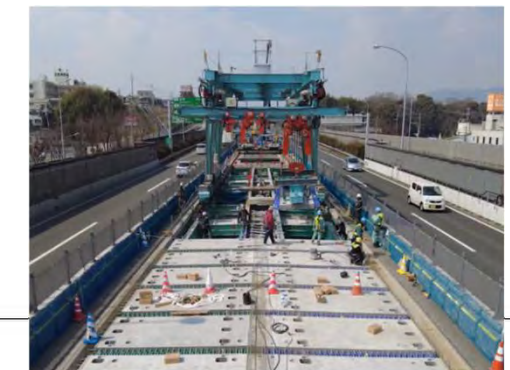
# Bridge Deck Renewal Work Zone Management

- ❑ If we were to implement conventional deck replacement methods, it would cause serious traffic congestion.
- ❑ 100-day road closures between Suita and Ikeda were performed for 2 years, while the Shin-Meishin Expressway and local road parallel to Chugoku Expressway served as detour routes.
- ❑ For a 6-lane section between Ikeda and Kobe cities, 2-lanes for each direction was secured during the construction.

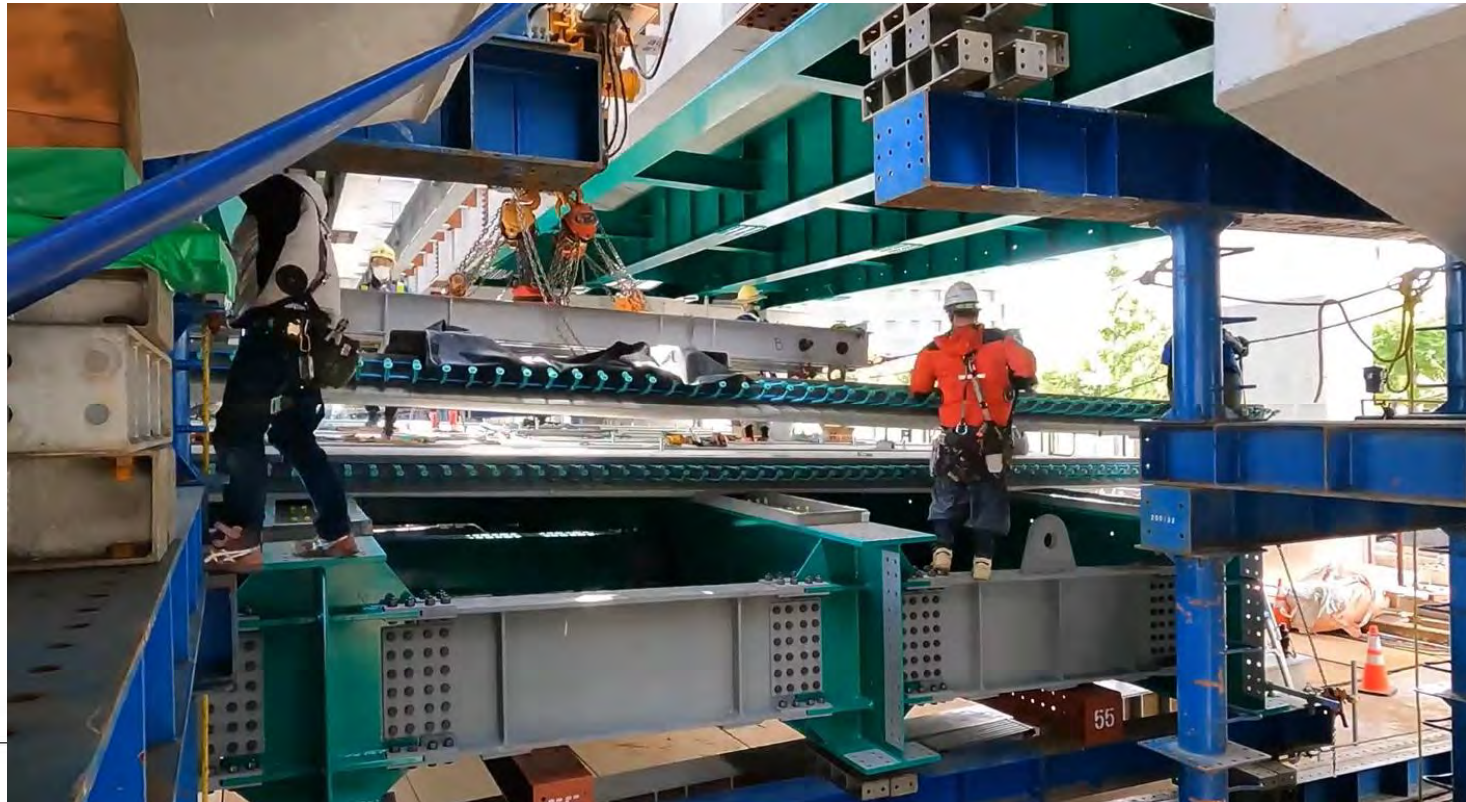
# Bridge Jack-Up for Accelerated Bridge Construction

- ❑ Before upcoming 30-day closures, newly fabricated girders were assembled in the work zone under the bridge, then are jacked-up near the existing girders.
- ❑ Once road closure is initiated, the existing decks and girders were removed, the new girders jacked further up to final height, and the precast decks were placed on top of the girder.
- ❑ This method reduced the time needed for placing new girders and scaffolding, leading to an efficient, safe, and short construction effort.
