Wider Application of Building Code for Safer Housing

Proceedings of National Workshop
23 August 2007 / Lima, Peru

National Workshop on the Housing Earthquake Safety Initiative

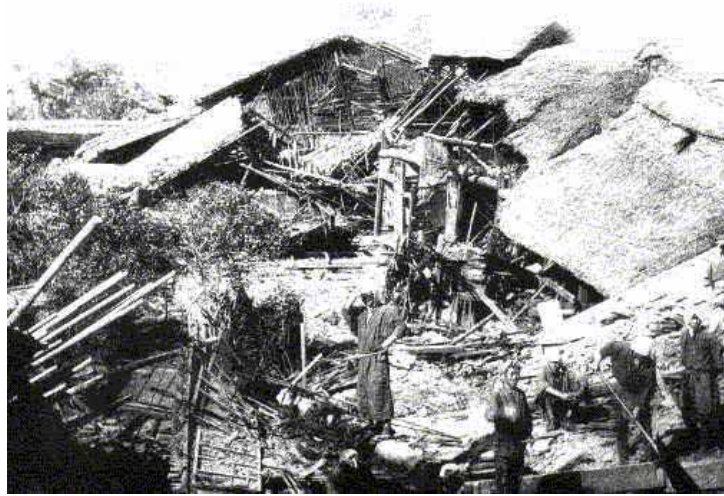
Photo 1: Damage of timber houses by the 1891 Nohbi Earthquake

A huge intra-plate earthquake (Nohbi Earthquake, M 7.9) hit Nagoya areas in 1891, which killed more than 7,000 and injured more than 17,000. More than 142,000 houses collapsed and more than 80,000 houses suffered heavy damage (see Photo 1). Then modern brick factories and buildings were severely damaged in Nagoya. John Milne observed that "... buildings on soft ground ... suffer more than those on the hard ground." and pointed out that "... we must construct, not simply to resist vertically applied stresses, but carefully consider effects due to movements applied more or less in horizontal directions." Although he stressed the need of seismic design, no quantitative design forces were proposed after this earthquake.

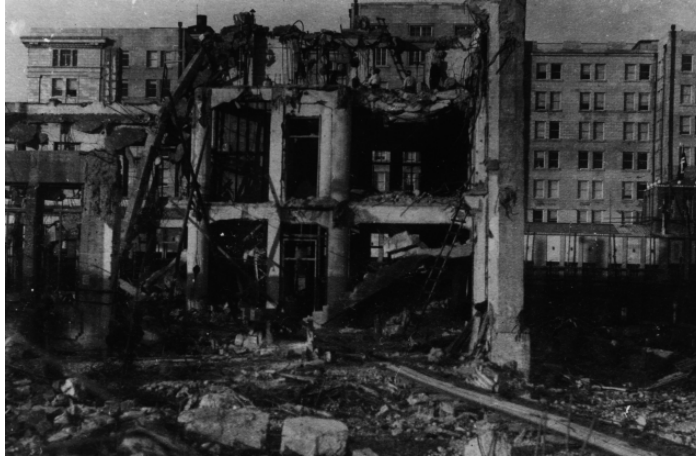
Photo 2: The Naigai Building near completion collapsed

The 1923 Kanto Earthquake (M7.9) caused significant damage in Tokyo and Yokohama. Approximately 105,000 were killed dominantly by fire. The damage by fire was quite large because the earthquake occurred just before noon. The Naigai building collapsed, which was nearly completed at the time of the earthquake using U.S. construction method (Photo 2). The statistics of damage on reinforced concrete buildings in Tokyo revealed that only 22 out of 553 R/C buildings suffered heavy damage (Table 1) although the buildings were not designed for earthquake forces. In other words, the intensity of ground motion must be not so large in Tokyo, approximately 100 km away from the epicenter.

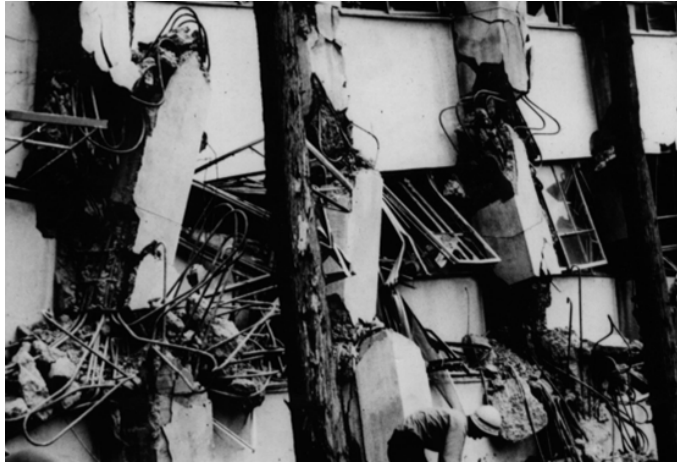
Photo 4: The Hakodate Technical University building collapsed after the 1968 Tokachi-oki Earthquake

The 1968 Tokachi-oki Earthquake (M7.9) hit the northern part of Japanese main island, causing damage to reinforced concrete buildings (see Photo 4), which were then believed to be earthquake resistant and safe. No one was killed in reinforced concrete buildings, but the government as well as researchers and engineers were surprised by the failure. Therefore, the Ministry of Construction (current MLIT) organized a national project, involving researchers in universities, national research institutes and construction companies, to study the cause of the damage in reinforced concrete buildings and the method to prevent the brittle failure.

On the basis of research, the Building Standard Law Enforcement Order was revised in 1971 to require narrow spacing of column ties. At the same time, it was generally recognized that the design requirements should be improved to reduce the damage of new construction, but that the existing buildings designed and constructed in accordance with old requirements should be retrofitted. Therefore, research efforts were made after the 1968 Tokachi-oki Earthquake, to develop (a) vulnerability assessment procedures for existing buildings, and (b) methods to strengthen vulnerable buildings. It was also studied (c) to evaluate damage levels of affected buildings in order to judge if the building could be immediately occupied for use and (d) to repair and strengthen damaged structures to the performance level required for new construction. The standard for vulnerability assessment for reinforced concrete buildings was published in 1977.

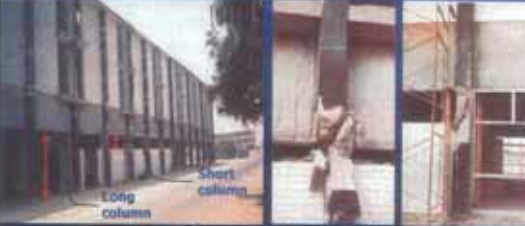
Lima - Peru, earthquake 1974

FAILURES FROM SHORT COLUMNS

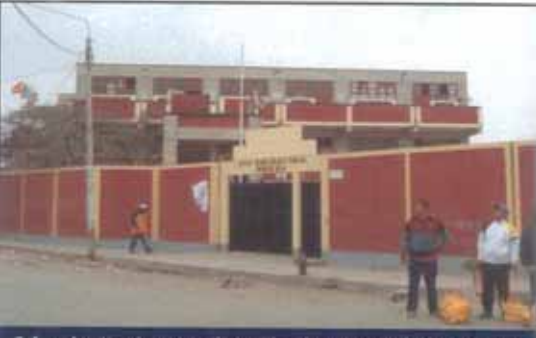
Safe educational center designed using the 1997/2003 Seismic Design Code. Notice that in the flexible direction there are 2cm slits between the RC walls and apron walls.
